SAIB: NE-16-19

Date: July 22, 2016

SUBJ: Turbine Engine Compressor Section – Stator Nozzle Distress

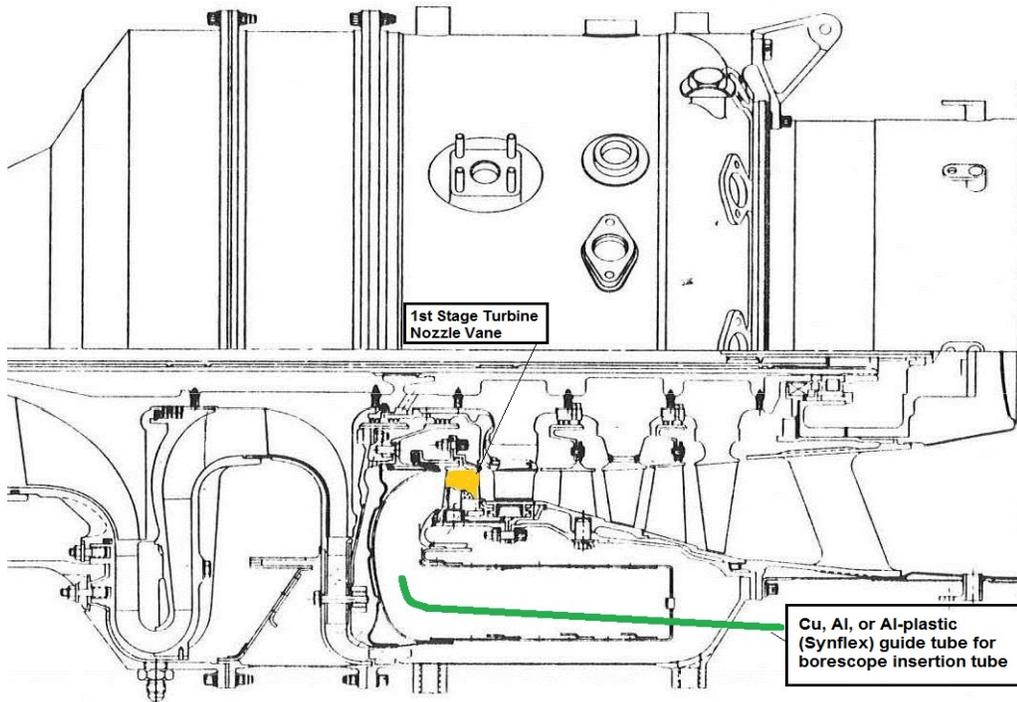
Figure 1. Cross-section of TPE331-11U Engine Power Section with Borescope Guide-Tube in Combustor

The flex insertion tube must be used with an appropriately sized guide tube as shown in Figure 1 below. When selecting a flex insertion tube, it is important to note that larger diameter tubes allow more light at the inspection site, but will have less flexibility. Synflex guide tubing provides the strength and flexibility of aluminum tubing and can be bent by hand. Some borescope suppliers may provide properly-sized Synflex tubing.

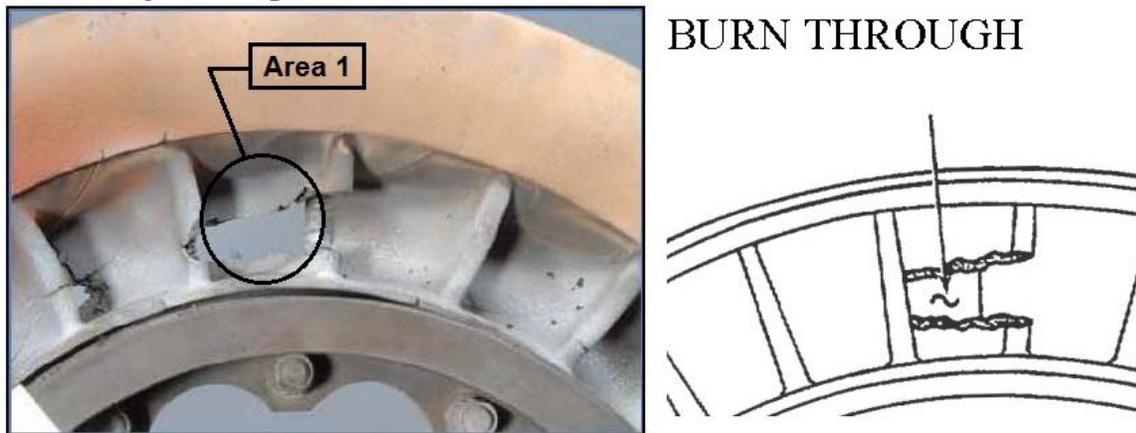
Area 1: Stator nozzle vane burn-through; unacceptable and unserviceable

Figure 2. 1st Stage Turbine Stator Nozzle with Nozzle Vane Burn-through

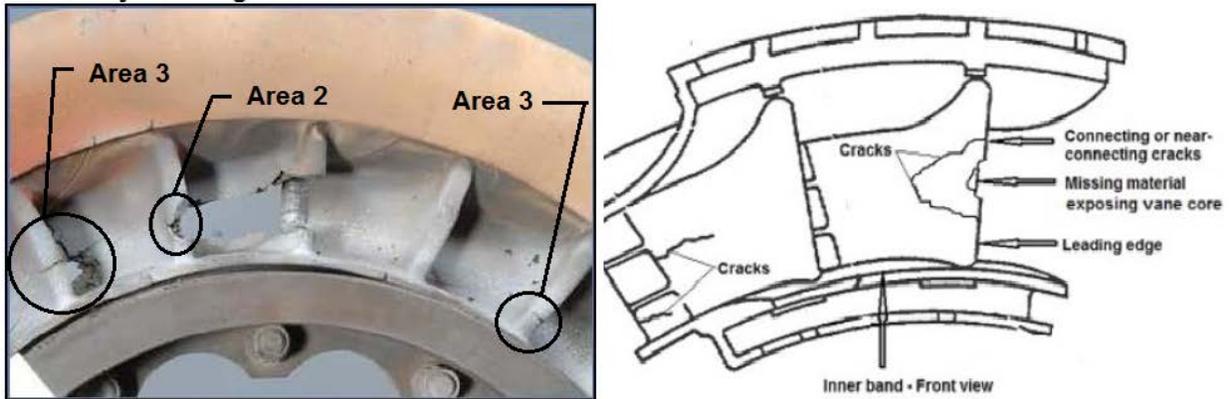
Area 2: Missing material exposing vane core; acceptable, but re-inspect at next fuel nozzle inspection interval

Area 3: Blisters, leading or trailing edge cracks, or connecting or near-connecting cracks; acceptable, but re-inspect at next fuel nozzle inspection interval

Figure 3. 1st Stage Turbine Stator Nozzle with Nozzle Vane Distress

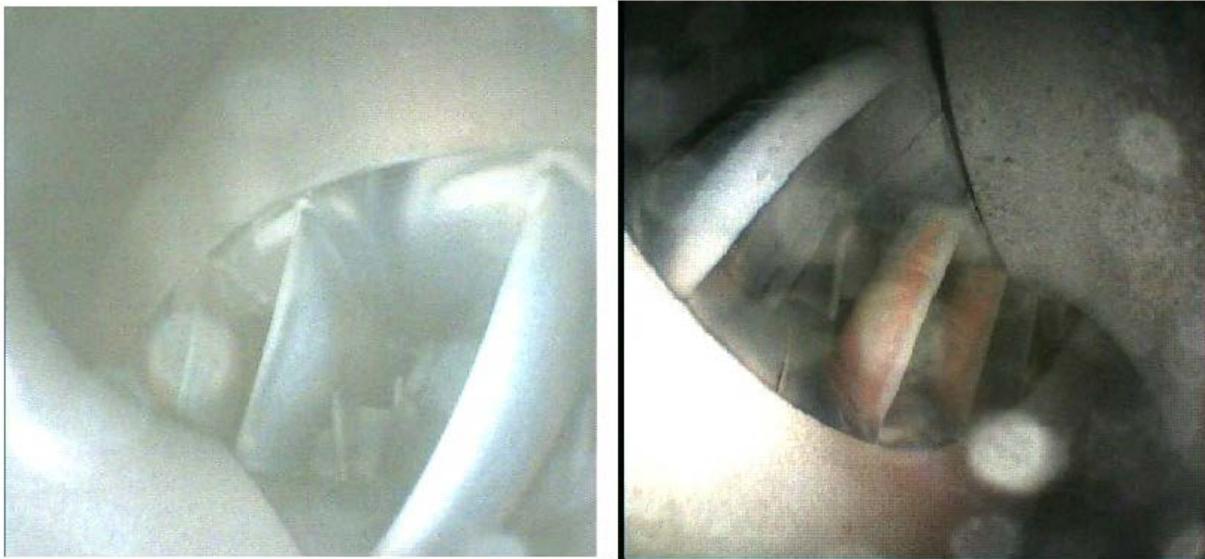
Figure 4. 1st Stage Turbine Stator Nozzle with Acceptable Nozzle Vanes
