AIRWORTHINESS BULLETIN

AWB 72-003 Issue 2 – 27 September 2016

Rolls Royce (Allison) 250 Series Engine Outer Combustion Case (OCC) Failures

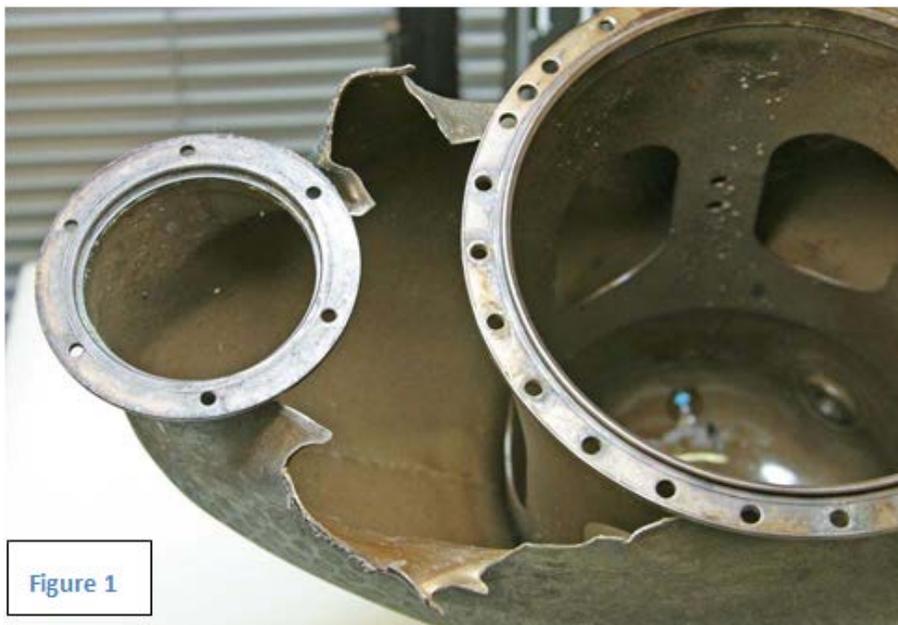
Figure 1

Figure 1. RR 250 C47B OCC Rupture failure (RH Side) Source: ATSB AO-2008-067.

The OCC rupture failure at Talbot Bay, Australia, occurred immediately after take-off from a ship's heli-deck, and resulted in complete engine power loss. The helicopter ditched in the sea and turned over with passengers trapped inside the cabin.

The ATSB final report confirms that the rupture failure originated from somewhere either under or adjacent to the reinforced area of the OCC 'armpit' area on the inside bend of the duct, close to the welded seam. See Figures 2&3, which show cracking in the 'armpit' area of the other duct of the same ruptured OCC installed on the occurrence engine.

A metallurgical examination of this combustion case found that the rupture failure occurred as a result of high cycle fatigue cracking, due to alternating pressure cycles in the combustion section of the engine as part of normal engine operation, and had been growing for some time. The cracking had started from a point immediately beside the brazed wire patch on the left armpit area and had extended for about 59 mm before rapid OCC failure. Source: ATSB AO-2008-067

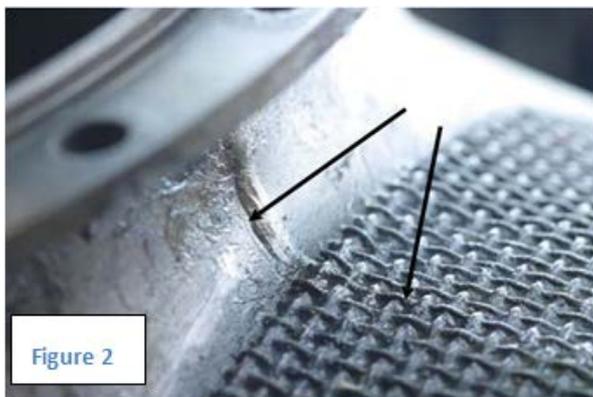
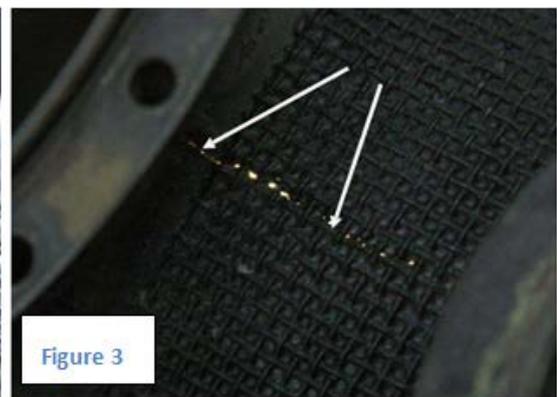
Figures 2 and 3 Depict RR 250 C47B OCC (LH side) showing two views of cracking in the same OCC duct shown in Figure 1. Fig 2 shows external indications, Figure 3 the same crack viewed with a strong light placed inside the OCC. (Source: ATSB AO-2008-067)

However, the manufacturer, Rolls Royce, has estimated that the power loss as a result of a typical 51 mm long crack as shown in Figures 2 & 3 would be about 1%, which the manufacturer considers would probably not be detected during the daily power assurance checks. (Source: ATSB Report AO-2008-067)

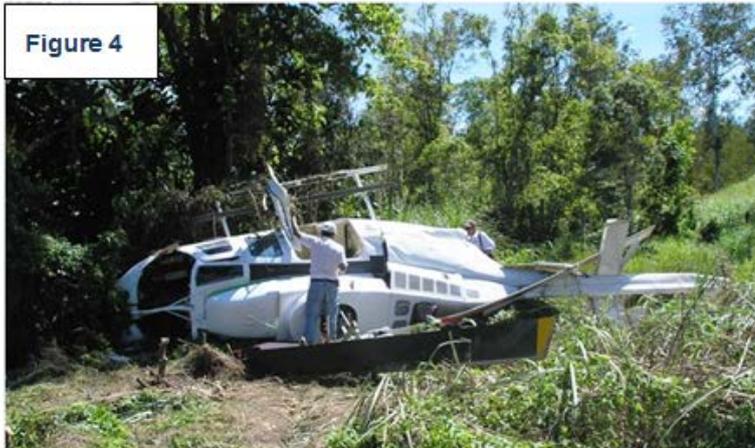
On 28 July 2008, A Bell 206 L4 helicopter was departing the remote village of Oruribo, approximately 150 km East of Port Moresby, Papua New Guinea (PNG). Shortly after lift-off and while entering transition to climb, the pilot heard the engine wind down with immediate loss of power, and prepared to make a run-on autorotation landing on a grassy patch of open ground on a river bank. The helicopter rolled over during the landing due to the slope of the landing area. Several of the passengers from the village sustained injuries and the helicopter was deemed a total loss. It was later established that the outer combustion case (OCC) had ruptured. Figure 4 & 5 (above).

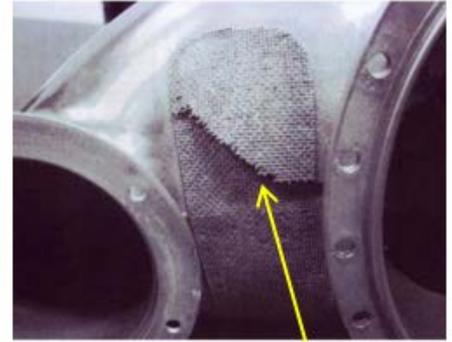
Figure 5, (above) The OCC had ruptured through wire mesh patch

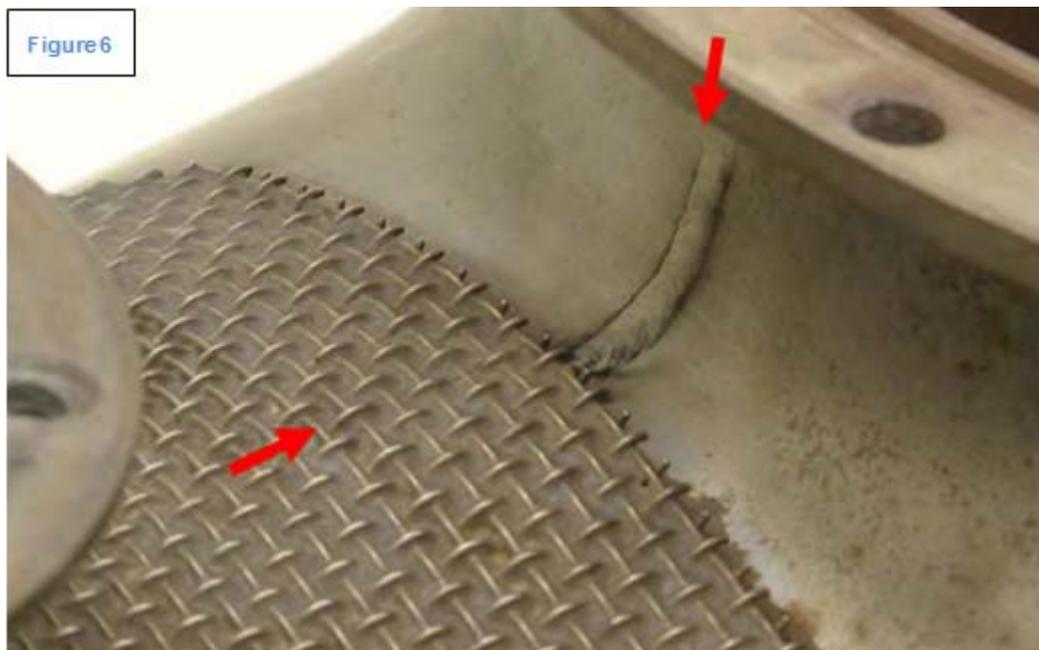
The ATSB report AO-2008-067 includes an investigation into another OCC duct which was removed upon discovering a crack which ran along one edge of the weld line. (Figure 6).

Figure 6 - Sikorski S-76-A / Rolls Royce (Allison) 250 C47B.

“No1 engine outer combustion case cracked for approximately 12.7mm (0.5in) at weld line. Crack extends 6.35mm to 12.7mm (0.25in to 0.5in) into reinforced wire patch area. Found during inspection IAW AWB 72-003.” (Sic).

The OCC currently does not have a retirement life and is an 'On Condition' item. The continuing airworthiness of the OCC depends entirely on continually inspecting the OCC to detect cracking before the OCC fails in service. (See AWB 02-001 'On Condition Maintenance'). Unfortunately, the factors which determine when cracks initiate, and the rate at which cracks develop to the point of combustion case leakage, power loss and catastrophic failure are difficult to determine, but appear mainly related to pressure cycles, such as starting. Any cracked OCC should be immediately removed from service.

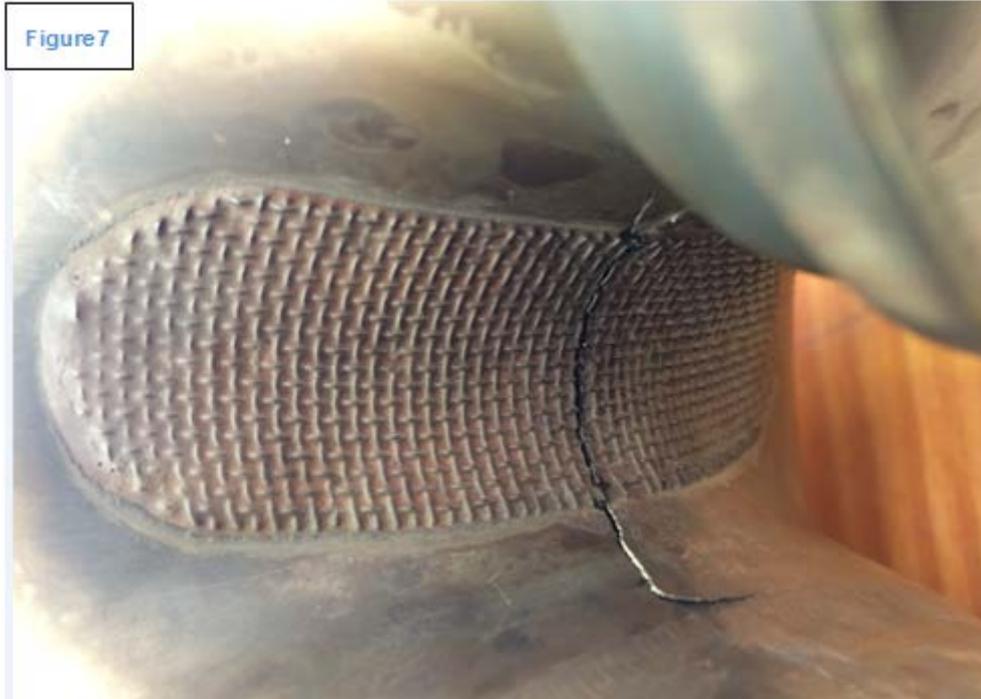
Figure 7 - AS355 F1; RR 250-C20F

SDR text: “High TOT noticed during cruise. Power check was c/o and failed to make power. During investigation into power loss it was discovered that the combustion can was cracked”. (Sic)

- Not rely on loss of power and increasing turbine outlet temperature (TOT) to detect the initial stages of OCC cracking.
- Include an inspection of the OCC for cracking when troubleshooting loss of power and increased TOT.
