SUBJ: Electrical Power/Electrical Power System Wiring

Introduction

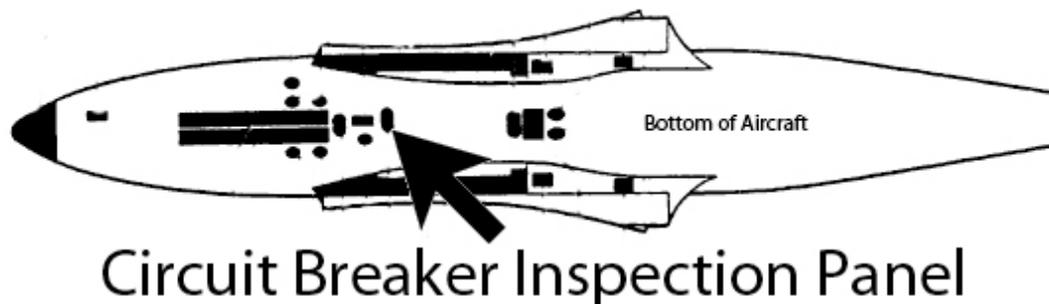
Figure 1 – Location of Circuit Break Inspection Panel

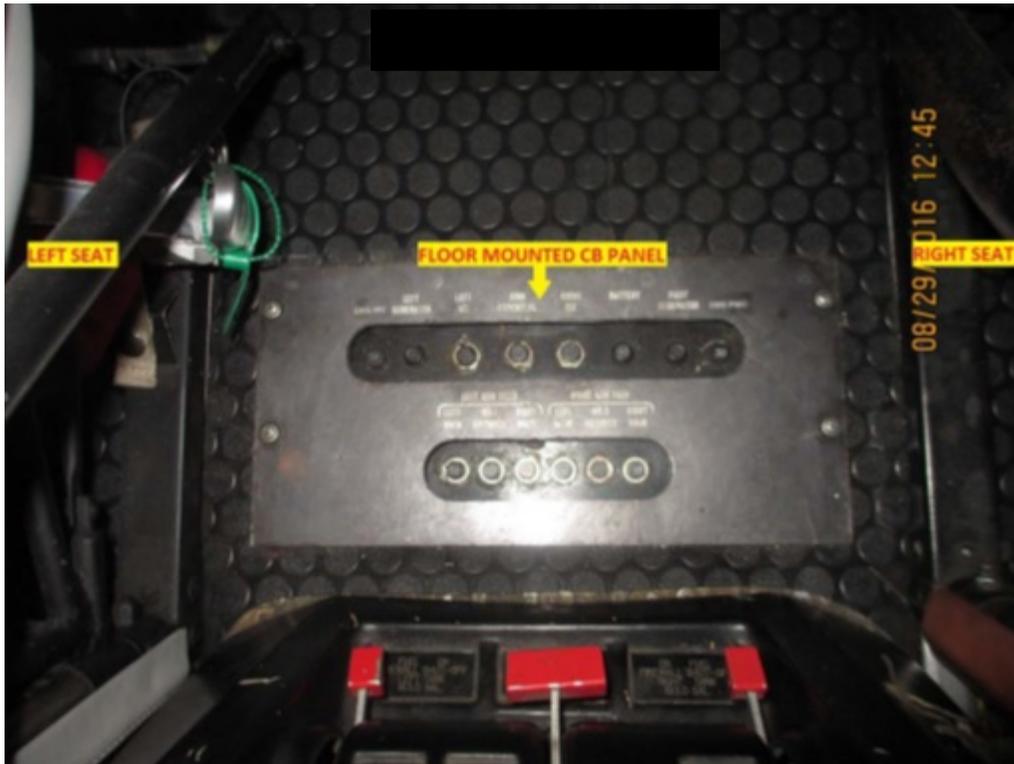
Figure 2 – Example of Floor Mounted CB Panel – Interior (1981 and later production)

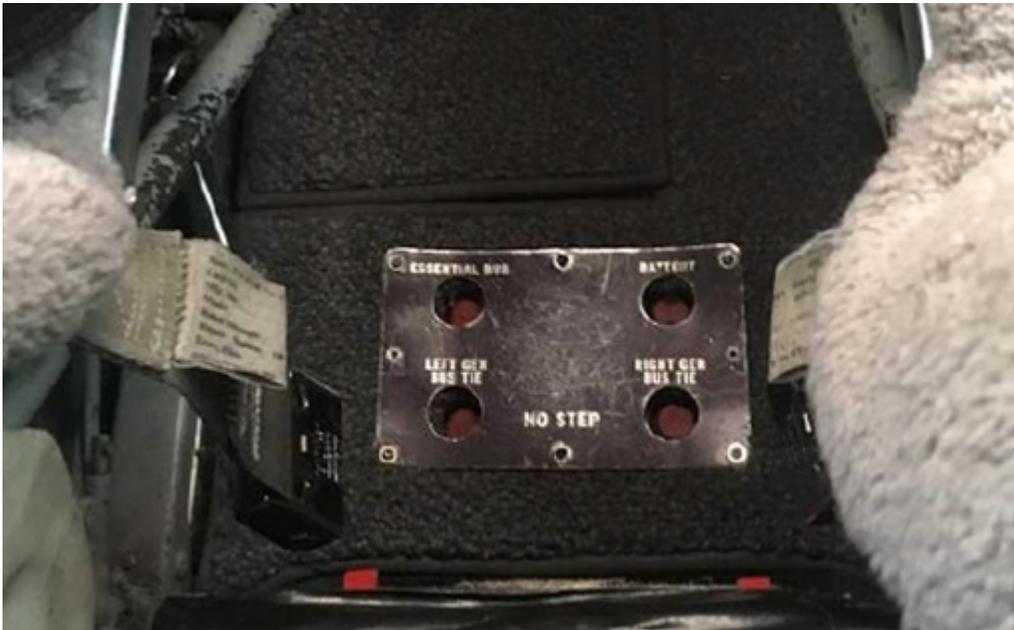
Figure 3 – Floor Mounted CB Panel – Interior (Typical of pre-1981 production)

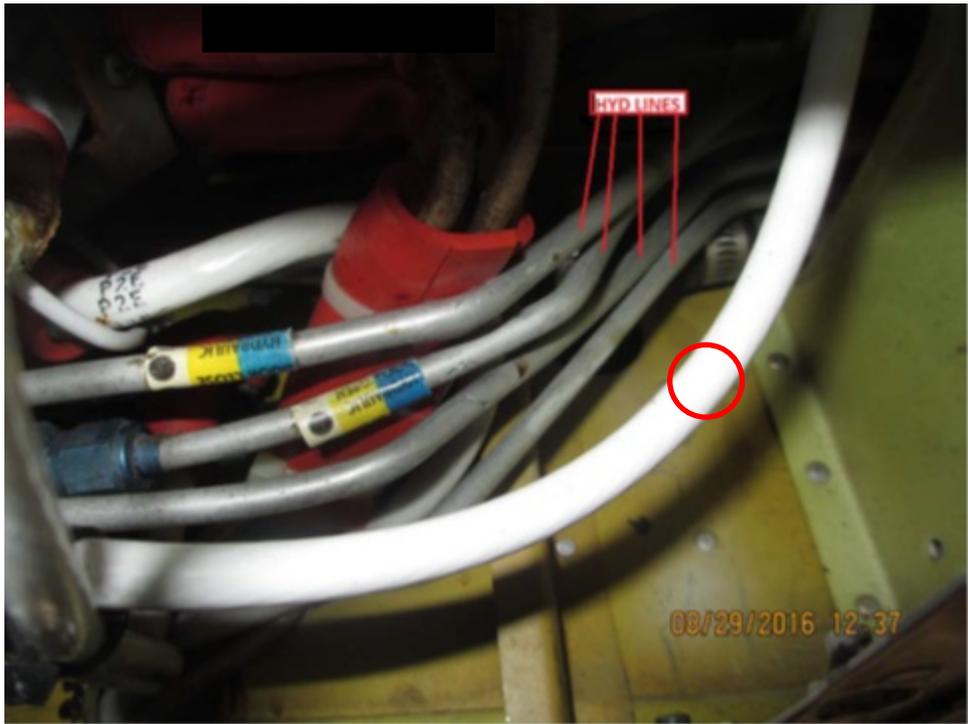
Figure 4 – View of the Hydraulic Lines in close proximity with electrical wires

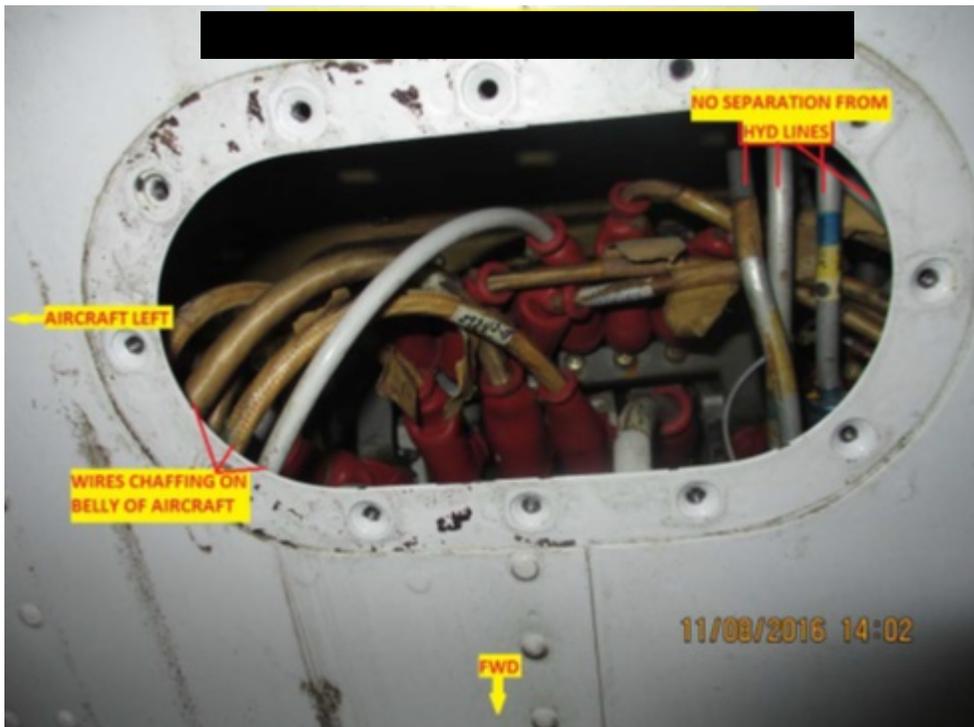
Figure 5 – View of the Area with inspection panel removed

- Inspections of the area shown in Figure 5, a mirror, a suitable light source or other equipment (small cameras, borescopes, magnification, etc.) capable of providing equal or better resolution.
- Inspections of the condition of all wiring.
- Repair or replacement of any wires with chafing, burning, breaks in insulation, corrosion, or any other apparent damage.
- Inspections for loose, corroded or broken terminals and repair or replacement on condition.
- A functional test on any electrical systems that were disturbed during any inspection.
- Reroute or rework as necessary to minimize the likelihood of chafing contact between adjacent components such as fluid carrying lines and airframe structure.
- Ensure proper hydraulic line and wire clearance is maintained. Use AC 43.13B – *Acceptable Methods, Techniques and Practices – Aircraft Inspection and Repair* as guidance.

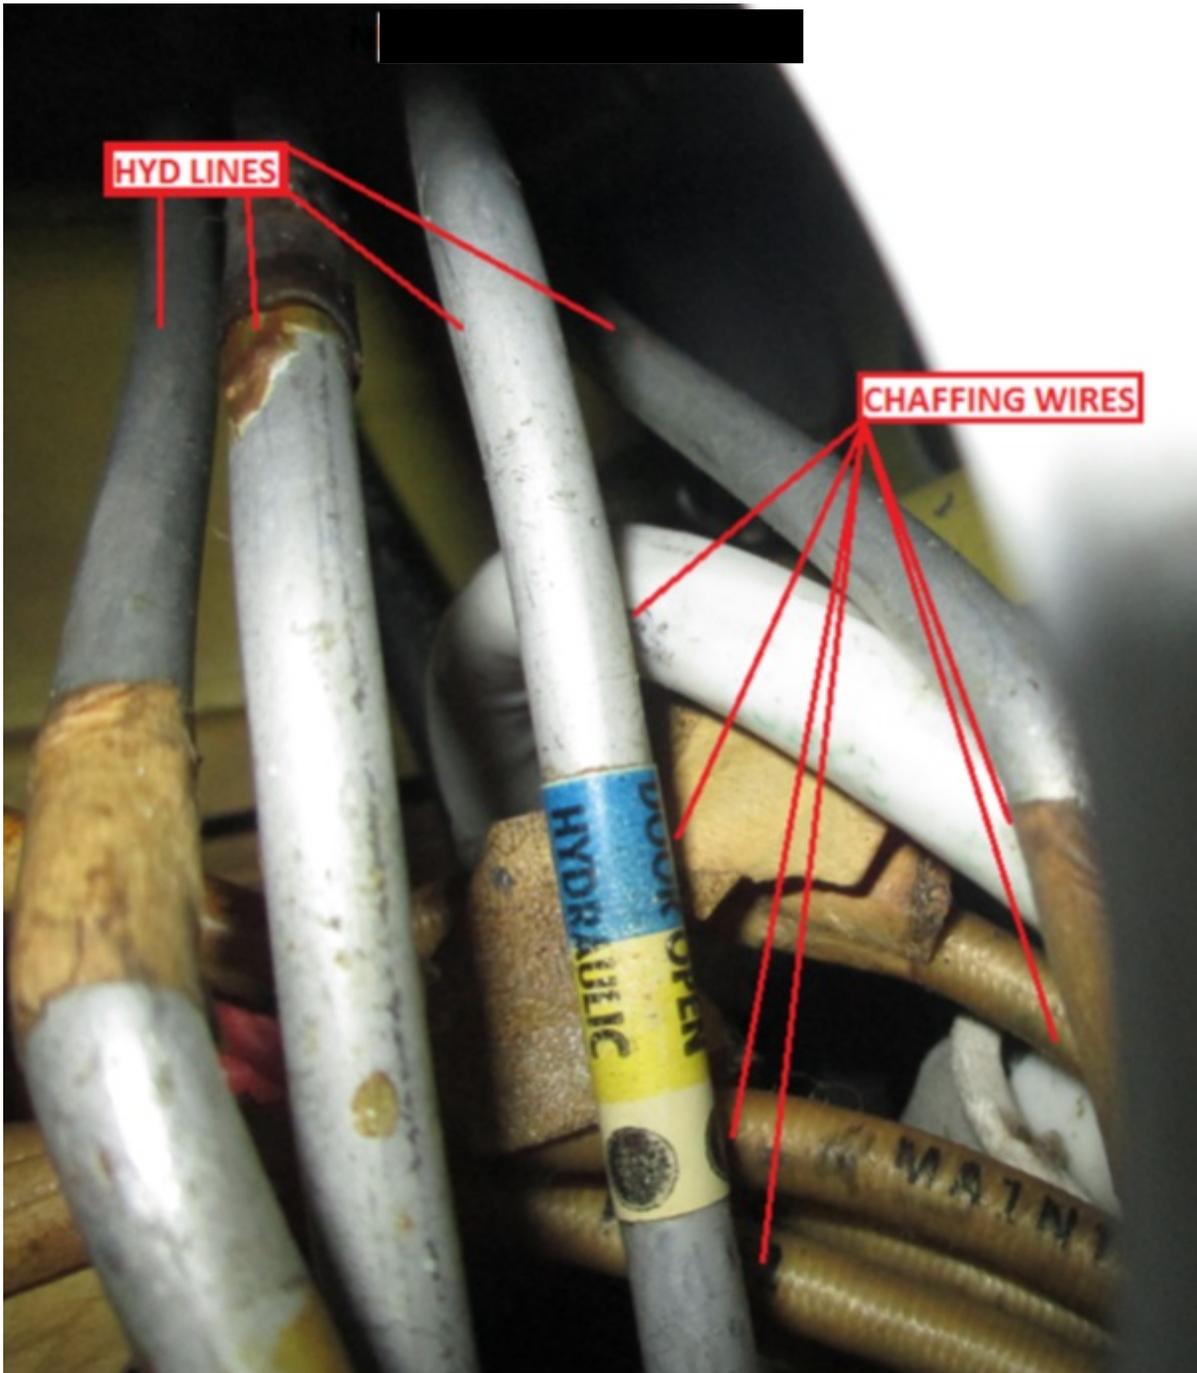
During inspections of multiple Piper Model PA-31T airplanes, several airplanes showed unacceptable wire separation from hydraulic lines and /or adjacent structure below the floor-mounted main power distribution CB Panel. The inspections also showed early signs of chafing, which can lead to thermal stress and arcing in an area where flammable liquids are routed. These conditions could sustain an uncontrollable fire in an inaccessible area below the pressurized deck. Photos of the area are shown in the following figures.

Figure 6 – Chaffing wires on hydraulic lines
