SAIB: CE-17-16
Date: June 9, 2017

SUBJ: Main Landing Gear – Actuator Inspection

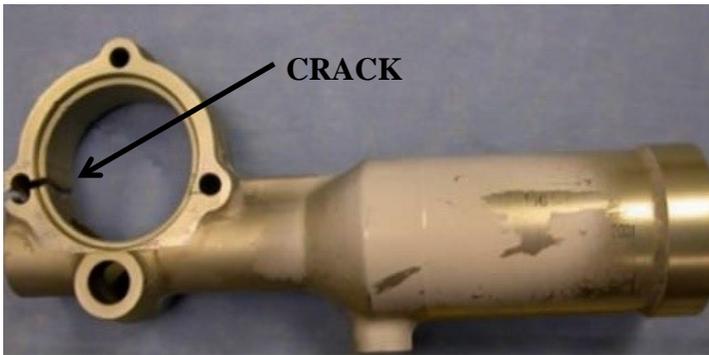
Figure 1

The FAA recently investigated an accident involving a Model 172RG airplane that had performed a gear up landing when the pilot was unsuccessful in getting the left main gear down and locked. During review of the landing gear system, investigators found the left main gear actuator (part number 9882015-2) housing cracked across the forward attach bolt hole. The crack allowed the actuator bore to open enough such that the piston would not engage the landing gear pivot sector sufficiently to move the gear. This failure will result in the affected side not being able to fully retract or extend through normal method or prevent use of the emergency hand pump.

Figures 1 and 2 reflect two actuators with the crack location most commonly noted that contributes to the gear malfunction.

The FAA recommends performing the inspections detailed in Textron SID 32-10-01 appropriate for the applicable airplane model. These inspections incorporate a combination of visual, fluorescent penetrant, and eddy current depending on the airplane model.

Initial inspection of the actuator is recommended at 3,000 hours time-in-service (TIS) or 10 years of age, whichever occurs first, for all models except the 210/T210 series airplanes produced from 1962 to 1968. Repetitive inspections are recommended every 500 hours (TIS) or 5 years, whichever occurs first.

Initial inspection of the actuator is recommended at 6,000 hours (TIS) or 10 years of age, whichever occurs first, for 210/T210 series airplanes produced from 1962 to 1968 with repetitive inspections at 1,000 hours TIS or 3 years, whichever occurs first.

Additionally, an inspection is recommended following any unplanned event such as a hard landing to ensure cracks have not developed.
