# AIRWORTHINESS BULLETIN

AWB 85-020 Issue 3 – 14 August 2017

Lycoming Engines - Connecting Rod Bushing Premature Wear

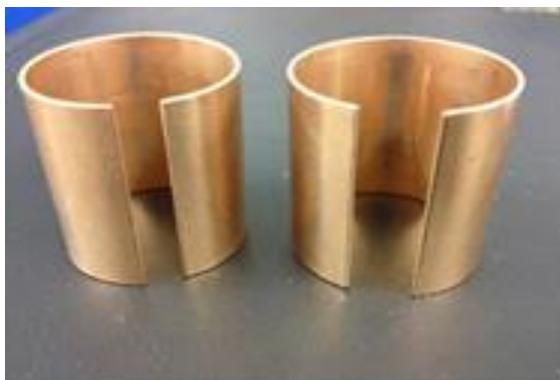
NOTE: Whilst the part number of the connecting rod bush has not changed, its physical appearance was recently altered. Stocks of Connecting Rod Small End Bush P/N LW-13923 received by Australian customers since early 2016 have a wide pre-set split line profile, (see Figure 1 and Figure 2 for more details).

Figure 1 - The bush on the right is a Connecting Rod Small End Bush P/N LW-13923, identifiable by the pre-set split line which is almost twice the width of the bushing previously received from Lycoming, shown on the left.

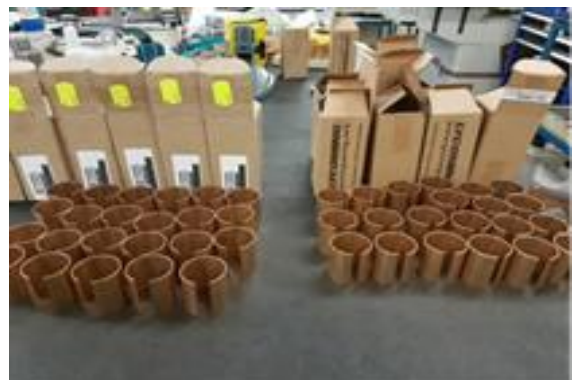
Figure 2 - Packaging on the left with new style bar coding containing bushing with the wide pre-set split line. Packaging on the right without bar coding previously received from Lycoming containing bushing with the narrower split line.

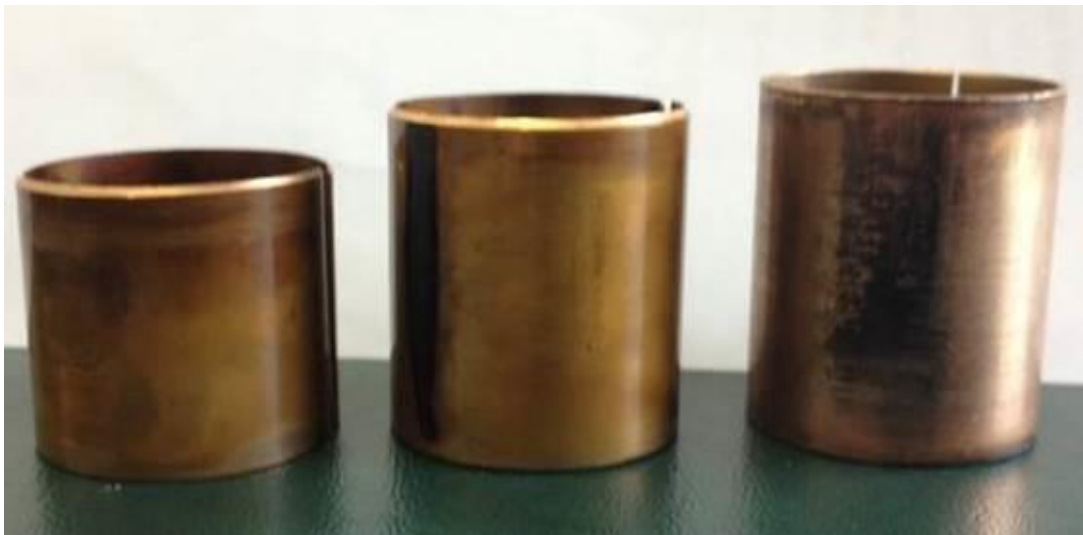
Group 1 Engines - Engines presented with one or more Small End Bushes (P/N LW-13923) that have migrated axially in their Connecting Rod. Migration of the Bushing results in the protruding edge being milled away by contact with the piston pin towers.

A reduction in the bearing surface creates an increasing bearing load on the remaining bushing, leading to an over-load condition and progressive break-up of the protruding bush edge through rocking of the piston pin as a result of the combustion process. The development and progression of the condition is relatively slow and predictable. See Figure 3 and 4 for more details.

Figure 3 - Three (3) P/No LW13923 Bushes from an O-360-J2A engine which had accumulated 1000 Hours since rebuild in September 2011, showing varying degrees of abrasive wear and consequential reduction in bush axial length. The bush on the right has a relatively unworn axial length.

- 1) At each engine oil change - Change the oil and filter and carry out inspection per the provisions of Lycoming SB 480F, (or subsequent).
- 2) When carrying out the engine oil and oil filter change procedure take appropriate precautions to drain the oil whilst the engine is still hot and strain the hot oil through a fine mesh screen filter.

- 4) Visually inspect condition and check security of connecting rod little end bushes in accordance with Lycoming SB No. 630A (or subsequent).
  - i. For engines with less than 800 Hrs TSO - At any time direct access to connecting rod little end bushes is available.
  - ii. For engines with more than 800 Hrs TSO – At next periodic inspection.
- 5) The use of spectrographic oil analysis to monitor engine component wear rates is also recommended. Refer to the latest revision of Lycoming Service Letter No. L171 for details.

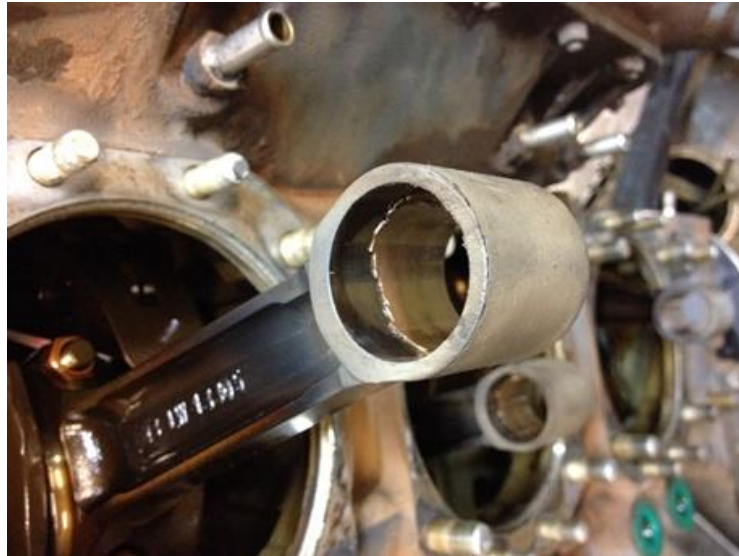
Figure 4 -Partially disassembled O-540-F1B5 engine with an accumulated Time Since New from September 2011 of 1031 Hours, showing material loss and breakup of the connecting rod little end bush. Four (4) of the six (6) bushes from this engine had varying degrees of material loss.
