# AIRWORTHINESS BULLETIN

AWB 85-022 Issue 1 – 18 October 2017

## Radial Engine Cylinder Head Inspection Practices

Pratt & Whitney R-1340, Wasp Engines, All Models.

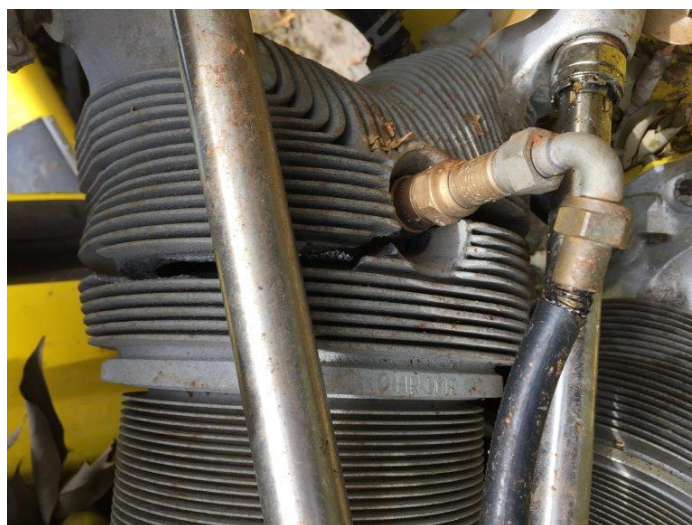
Figure 1.

Recent service experience has indicated that circumferential fin root cracking can also develop. This crack type can propagate in fatigue around the cylinder head and radially outwards until a major portion of the head fails in tension, (see Australian Transport Safety Bureau Aviation Investigation Report Number: AO-2017-009).

- 1) During each visual inspection required by AD/PW-P/19, also visually inspect between the cooling fins of the cylinder heads;
  - in the area of the exhaust port and valve housing, and
  - circumferentially around the lower portion of the cylinder, starting at the rear spark plug port.

If a crack is visible, or if black combustion leakage is found at the root area between two fins, the cylinder assembly should be replaced with a serviceable part, prior to further flight.
