AIRWORTHINESS BULLETIN

AWB 85-025 Issue 2 – 13 December 2018

Robinson R22/R44 Engine Intake Valve and Valve Seat Distress

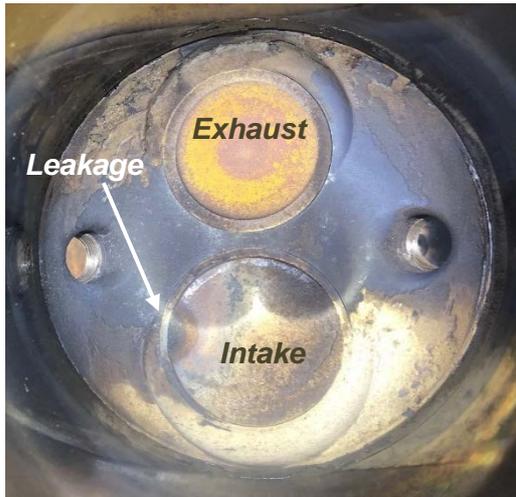
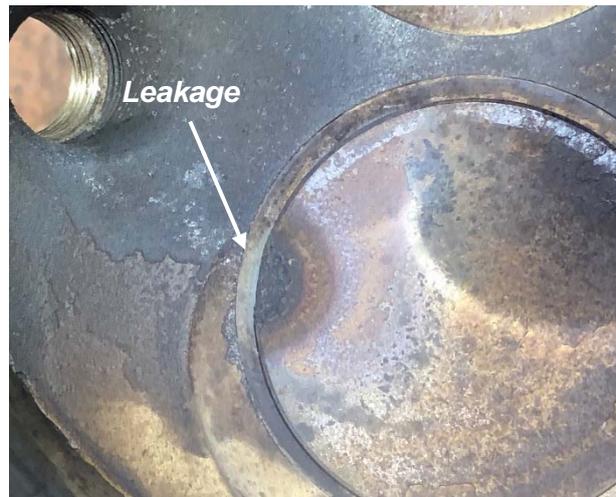
Combustion Chamber view on Intake Valve
Note crescent-shaped burn pattern due to severe and uneven heating at valve edge.
(Source: DRS No: 611852852)

The accumulated deposits are subsequently ignited with a flash-off event causing valve and/or valve seat damage (erosion). This enables combustion to continue past the unsealed intake valve into the intake manifold with a percentage of the fuel-air mixture being consumed within the manifold causing an induction backfire leading to power loss and airframe yaw.

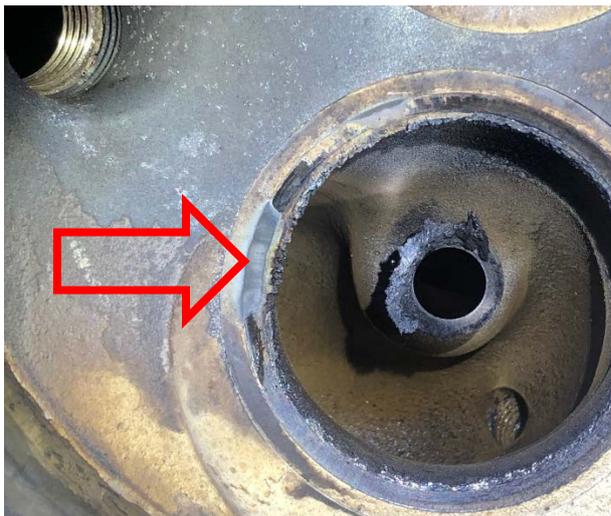
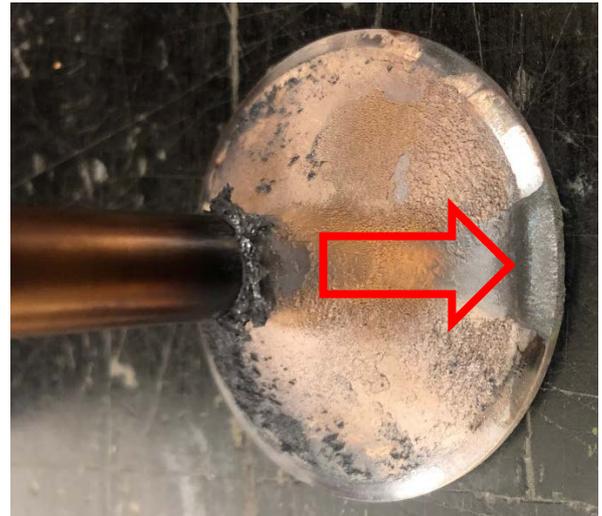
View showing corresponding Intake Valve seat face damage and carbon build-up
(Source DRS No: 611852852)

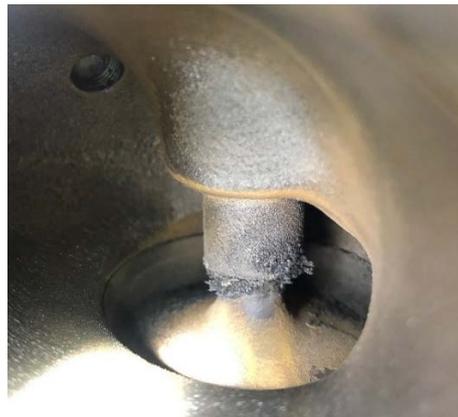
Figure 5

6. Current evidence suggests that ultimately the accumulation and hardening of intake valve deposits may prevent rotating of the valves during operation. The ability of the valves to rotate is inherent in the valve train design and this is essential to valve longevity as it helps prevent deposits from building up around the seat, which in turn results in the loss of compression.

1. With the spark plugs removed, position the piston at bottom dead centre at the end of the intake stroke.
2. Insert the borescope through the upper spark plug hole and inspect the intake valve and valve seat.
3. Inspect for signs of leakage or damage indicated by localised discolouration or erosion on the valve face and seat circumference. See previous example images.
4. Remove intake pipes and move the piston through the intake stroke whilst observing the valve through the intake ports.
5. Inspect for accumulation of carbon deposits around the valve stem, guide and fillet. See Figure 5.

If you find a burnt/damaged valve, closely inspect the valve tip (where the rocker arm contacts the intake valve) and associated rocker arm 'toe' for linear wear marks.
