# AIRWORTHINESS BULLETIN

AWB 63-002 Issue: 4 - 8 March 2019

## Bell 206 Freewheel Unit Failures - Mast Yielding / Main Rotor Separation

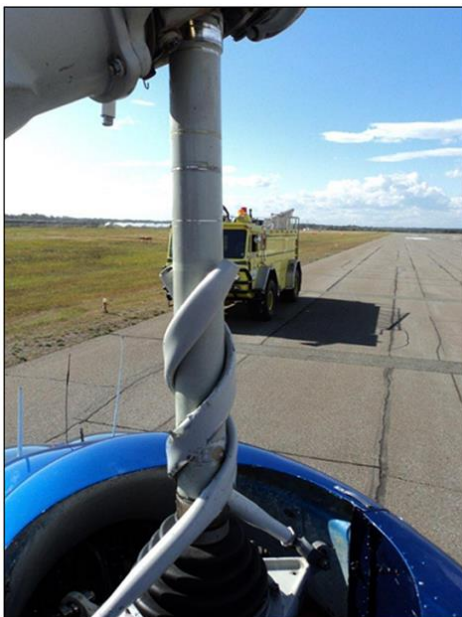
During the final stages of a practice power-recovery autorotation, the pilot rolled the throttle to full power. The engine spooled up to 100% but the free-wheel unit did not engage the engine to the transmission.

Rotor RPM decayed as the collective was raised to cushion the landing at the end of the descent, at which point the freewheel unit suddenly engaged.

The inertia built up by the engine was immediately resisted by the mass of the decelerating rotor system and the shock resulted in the main rotor head separating from the mast. The touchdown was firm and the helicopter slid about 5 feet.

Fig 1. - Main rotor mast to rotor head separation failure. Accompanying text is a summary based on TSB Aviation Investigation Report A11C0152.

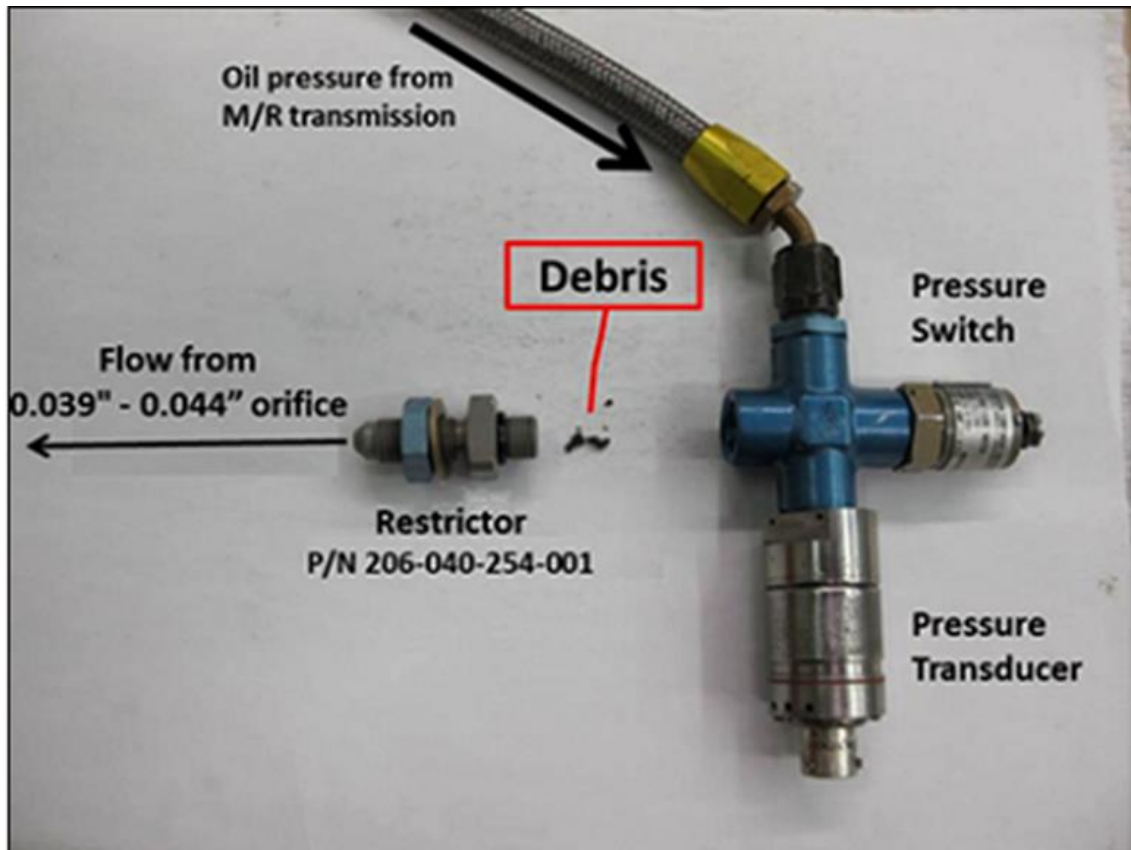
The investigation found that the free wheel unit had failed due to lack of lubrication caused by debris in the oil supply restrictor or oil jet, the same prime causal factor for freewheel failures and mast yielding in Australia.

Fig. 2 - General arrangement of the failed freewheel oil supply, also note the debris blocking the restrictor or oil jet. (Ref. TSB Aviation Investigation Report A11C0152).

1. In addition to the current AD requirements to inspect the one-way clutch oil supply orifice filter for cleanliness anytime an opening occurs to the freewheel oil supply between the restrictor and the filter, CASA recommends that the operator take action to ensure the filter is checked for cleanliness:
  - (i) Between 100 to 200 flying hours after the transmission has been opened for maintenance,
  - (ii) Following main transmission failure,
  - (iii) Whenever the main transmission is changed, or
  - (iv) The freewheel unit is removed or changed for any reason.
2. Activating the associated chip detector.

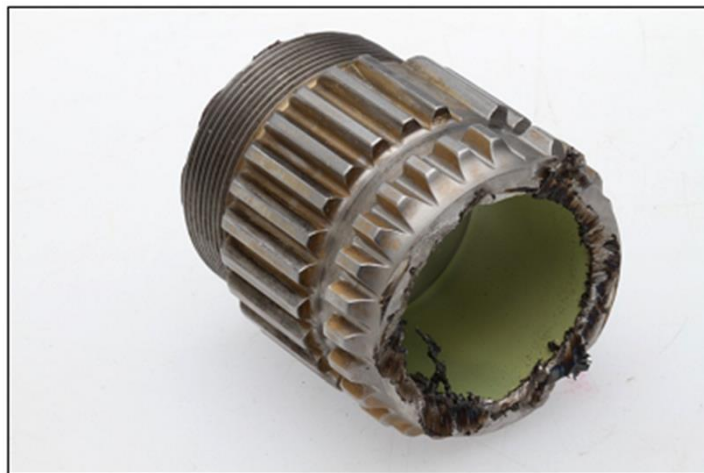
Free wheel failure of this kind usually results in a torsional yield failure of the main rotor mast, evidenced by a misalignment between the mast spline that engages with the main rotor head and the comparison spline in the mast below where the main rotor head engages with the mast splines. (See figure 3).

Fig. 3 - Upper mast stub which separated from the main rotor mast. (Ref. TSB Aviation Investigation Report A11C0152).
