# AIRWORTHINESS BULLETIN

AWB 85-025 Issue 3 – 7 March 2019

## Robinson R22/R44 Engine Intake Valve and Valve Seat Distress

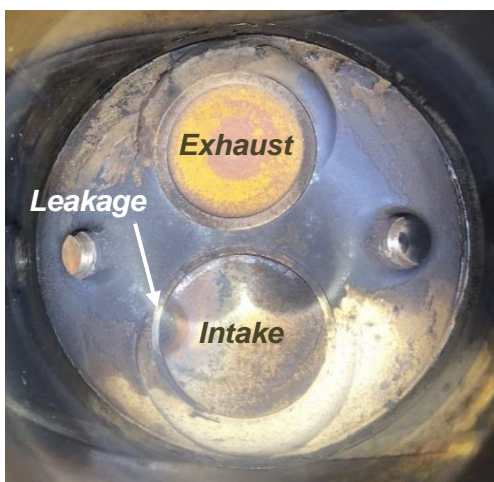
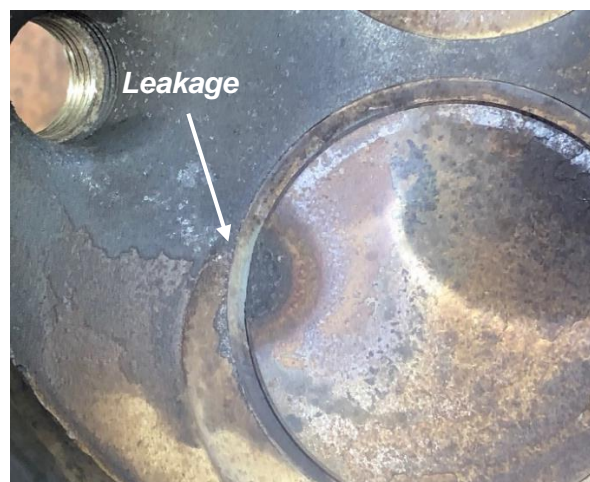
Combustion Chamber view on Intake Valve

Note crescent-shaped burn pattern due to severe and uneven heating at valve edge.  
(Source: DRS No: 611852852)

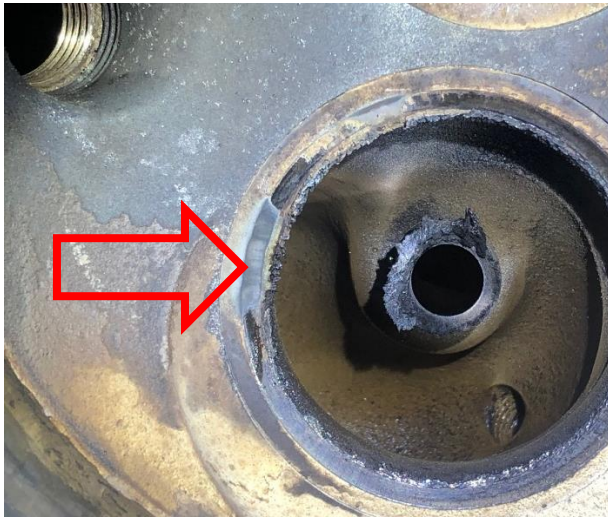
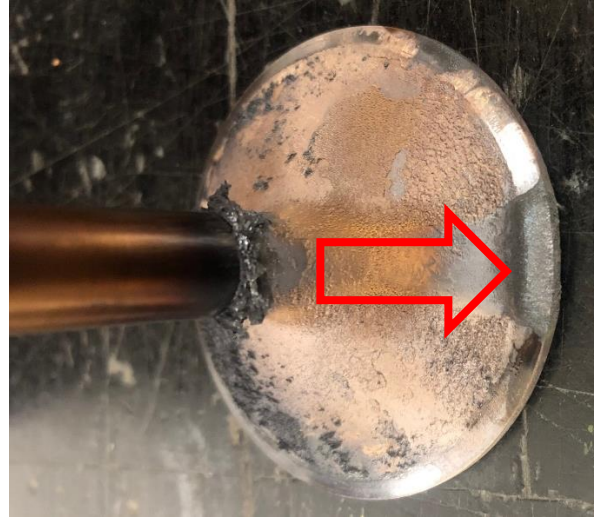
View showing corresponding Intake Valve seat face damage and carbon build-up  
(Source DRS No: 611852852)

The accumulated deposits are subsequently ignited with a flash-off event causing valve and/or valve seat damage (erosion). This enables combustion to continue past the unsealed intake valve into the intake manifold with a percentage of the fuel-air mixture being consumed within the manifold causing an induction backfire leading to power loss and airframe yaw.

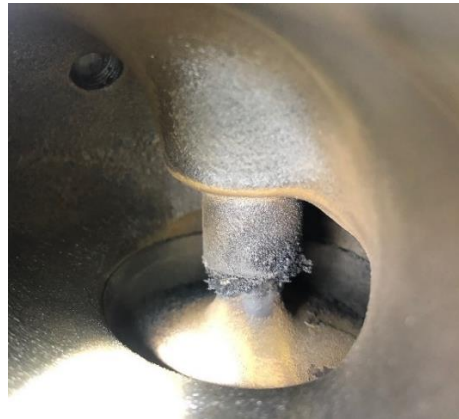
Figure 5

6. Current evidence suggests that ultimately the accumulation and hardening of intake valve deposits may prevent rotating of the valves during operation. The ability of the valves to rotate is inherent in the valve train design and this is essential to valve longevity as it helps prevent deposits from building up around the seat, which in turn results in the loss of compression.

2. Insert the borescope through the upper spark plug hole and inspect the intake valve and valve seat.
3. Inspect for signs of leakage or damage indicated by localised discolouration or erosion on the valve face and seat circumference. See previous example images.
4. Remove intake pipes and move the piston through the intake stroke whilst observing the valve through the intake ports.
5. Inspect for accumulation of carbon deposits around the valve stem, guide and fillet. See Figure 5.
