SAIB: SW-19-05
Date: April 4, 2019

SUBJ: Tail Rotor Drive System, Spline Damage

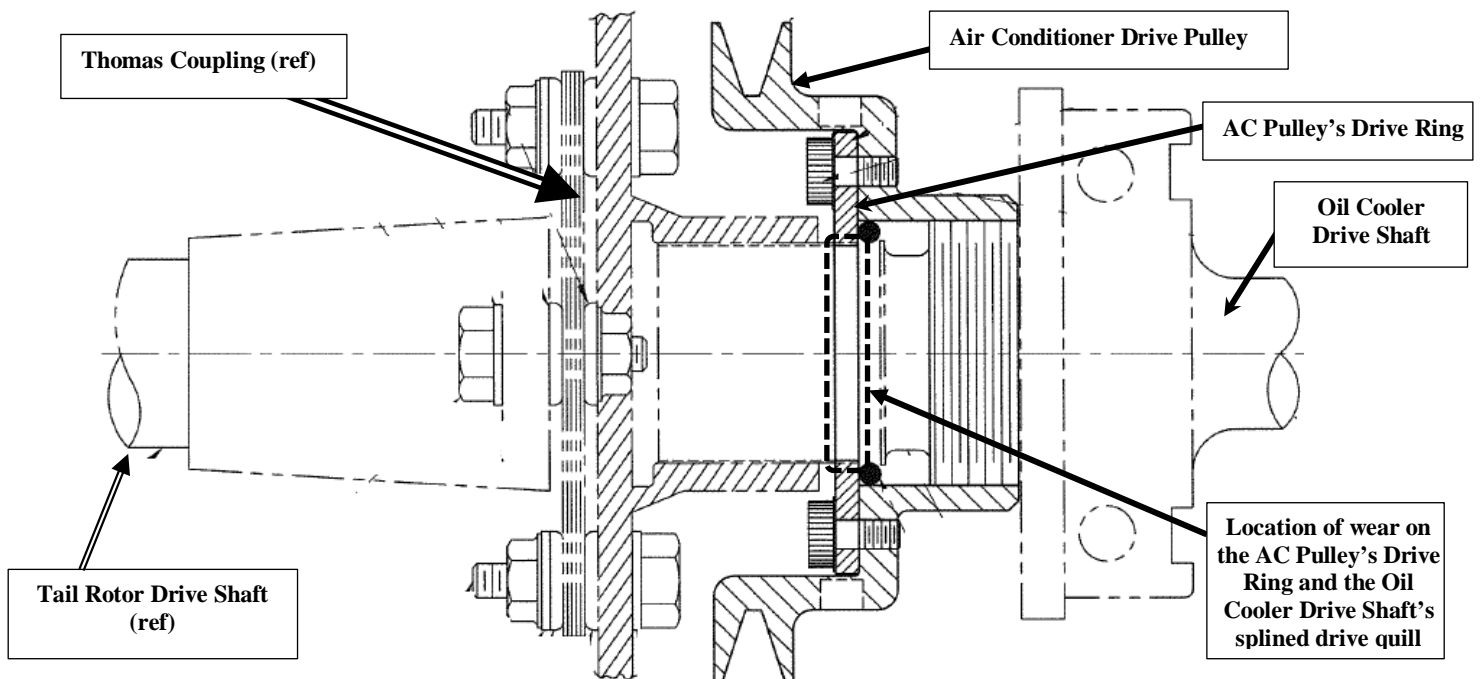
The Federal Aviation Administration (FAA) was notified of a number instances of the air conditioner pulley's locking system (AC Pulley's Drive Ring), which is installed on the Oil Cooler Drive Shaft's splined quill, causing excessive spline tooth wear to itself and to the respective mating splines on the quill. The reported damage does not affect the tail rotor drive shaft's Thomas coupling or the couplings connection to the Oil Cooler Drive Shaft.

The FAA recommends that all owners, operators, and maintenance personnel of the affected aircraft listed in the introduction of this SAIB adhere to inspection and time of accomplishment instructions of **Air Comm Service Bulletin SB206EC-18-07, Rev A or later revision “Bell 206 Air Conditioner Spline Inspection”**. The FAA further recommends that the Air Conditioner pulley’s lock ring be routinely inspected when normal routine maintenance per Bell Helicopter maintenance requirements allows access.
