AIRWORTHINESS BULLETIN

AWB 53-011 Issue 1 – 12 Jul 2019

Cessna 210 and 177 Wing Carry-through Spar

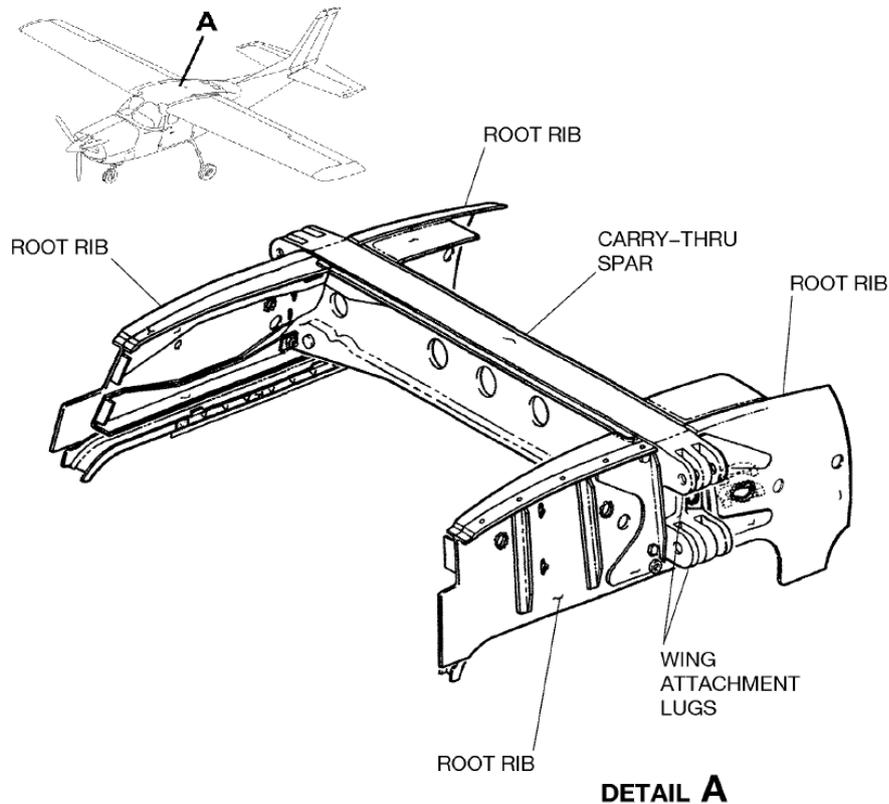
A recent fatal accident on an Australian registered Cessna T210M aircraft may have been caused by a fatigue fracture of the spar where cracking had initiated from a corrosion pit on the lower surface of the wing carry-through spar. The spar failed inboard of the right-hand wing attachment lugs where the lower cap transitions into a carry-through tension tie that connects to the left-hand wing attach lugs (Figure 1).

Figure 1: CESSNA Aircraft Company Model 210 Series (1970-1976) Service Manual Carry-Thru Spar Corrosion Inspection Figure 1 (Sheet 1) D2002-5-13 Temporary Revision Number 11 Aug 1/2011

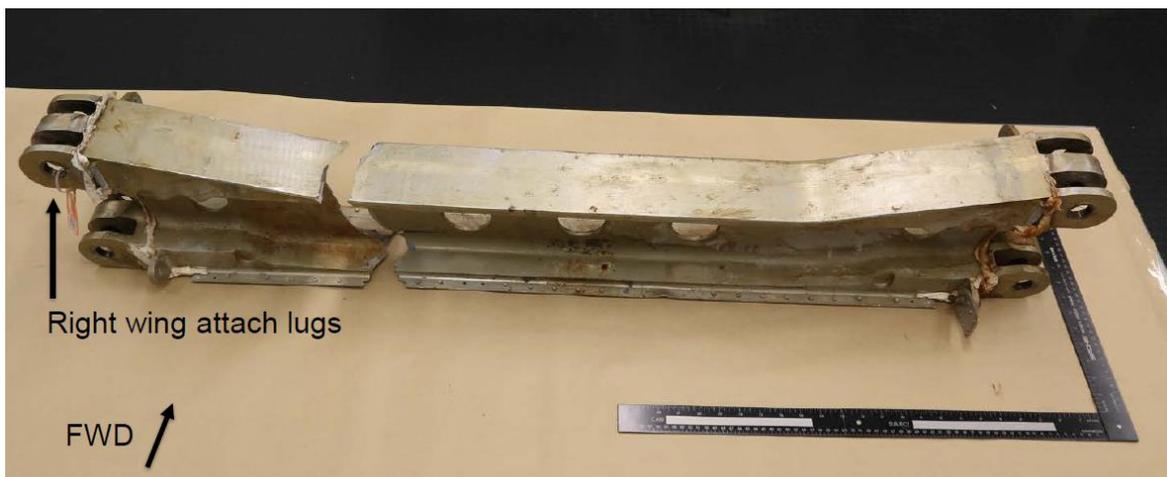
Figure 2: Photograph of Cessna T210M Fractured Carry-Thru Spar. View looking AFT at lower chord surface. Photo: ATSB AO-2019-026 Preliminary Report

Note: Preliminary investigation of the failed carry-through structure showed that a crack quickly grew to a critical size from a very small corrosion pit. Detection of any crack is likely to be very difficult, even with eddy current methods on the forging lower cap lower surface, as it will be in compression on the ground. It is recommended to mark out small zones on the lower surface and overlap the ECI probe path to ensure no areas are missed. The crack on the failed carry-thru spar propagated in the fore/aft direction across the lower cap lower surface.

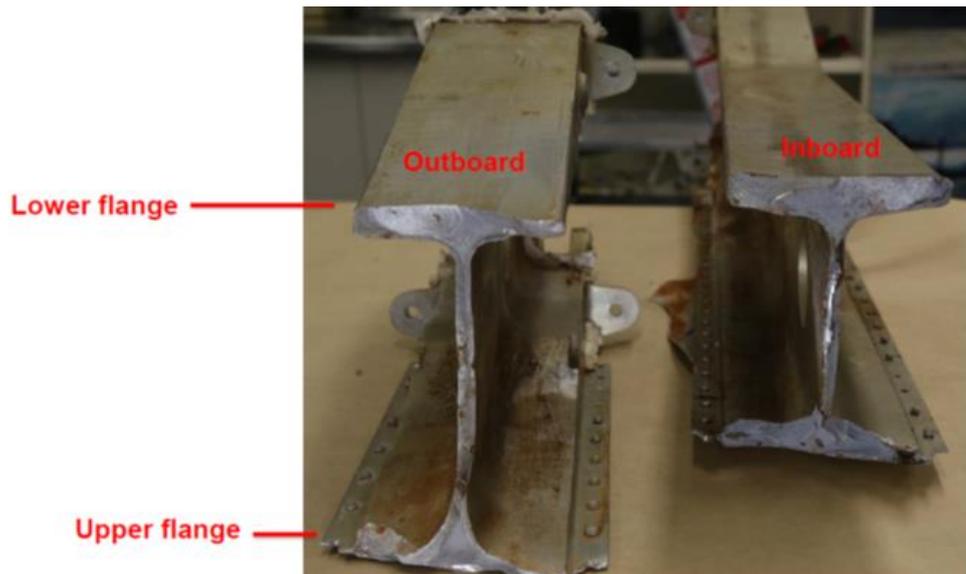
Figure 3: Photograph of Cessna T210M Fractured Carry -Thru Spar Fracture Surfaces
Photo: ATSB AO-2019-026 Preliminary Report

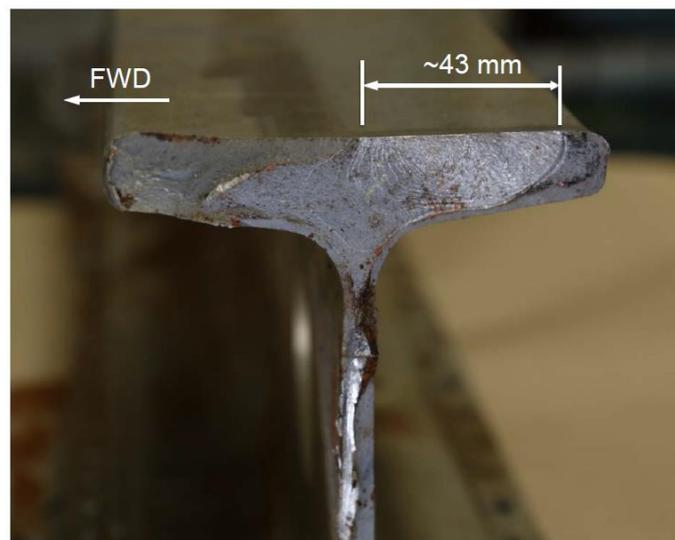
Figure 4: Photograph of Cessna T210M Fractured Carry -Through Spar INBD Fracture Surface.
Photo: ATSB AO-2019-026 Preliminary Report

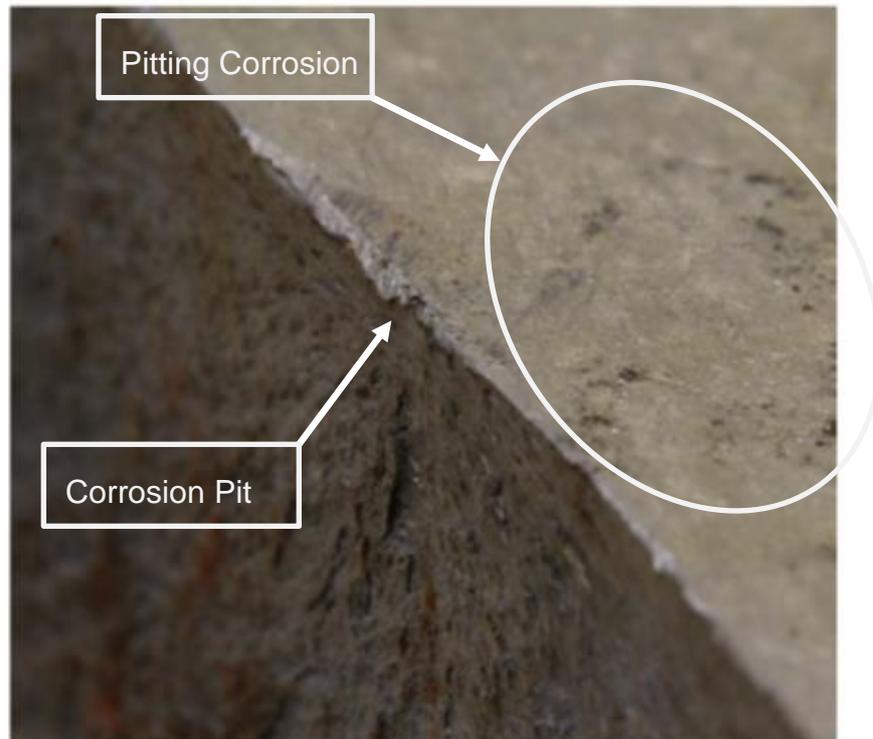
While the accident investigation is currently being carried out by the ATSB, a preliminary ATSB report shows that the spar had experienced very minor surface corrosion pitting on the lower cap lower surface and that no other mechanical damage was found at the fracture surface. The corrosion pit was 1.82mm long and 0.3mm deep. Figures 2 through 4 refer to the fractured spar, and Figures 5 and 6 show pitting corrosion evident on the lower surface of the lower spar cap.

Figure 5: Photograph of Cessna T210M Fractured Carry -Through Spar INBD Fracture Surface.
Pitting Corrosion Pits evident.
Photo: ATSB AO-2019-026 Preliminary Report

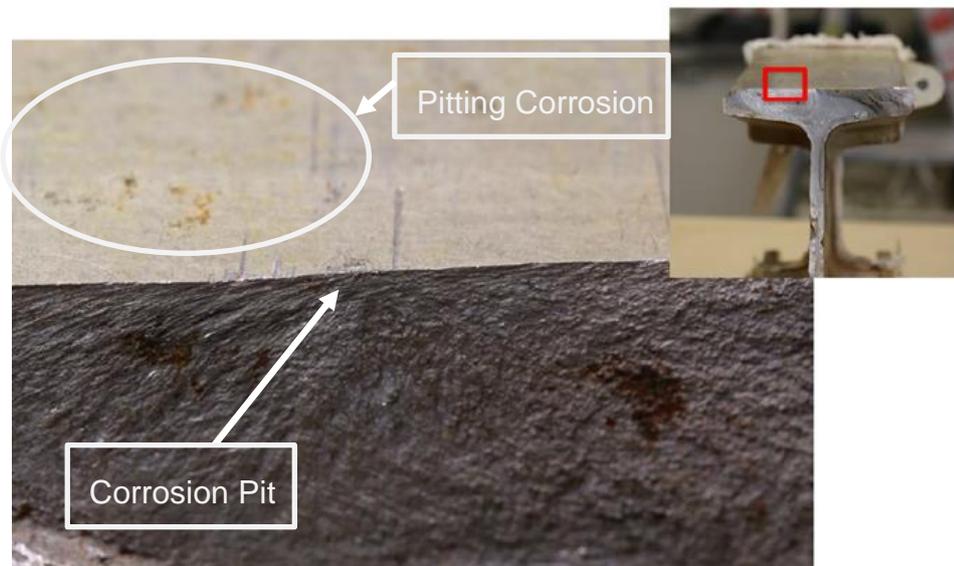
Figure 6: Photograph of Cessna T210M Fractured Carry-Through Spar OUTBD Fracture Surface
with Corrosion Pit evident.
Photo: ATSB AO-2019-026 Preliminary Report

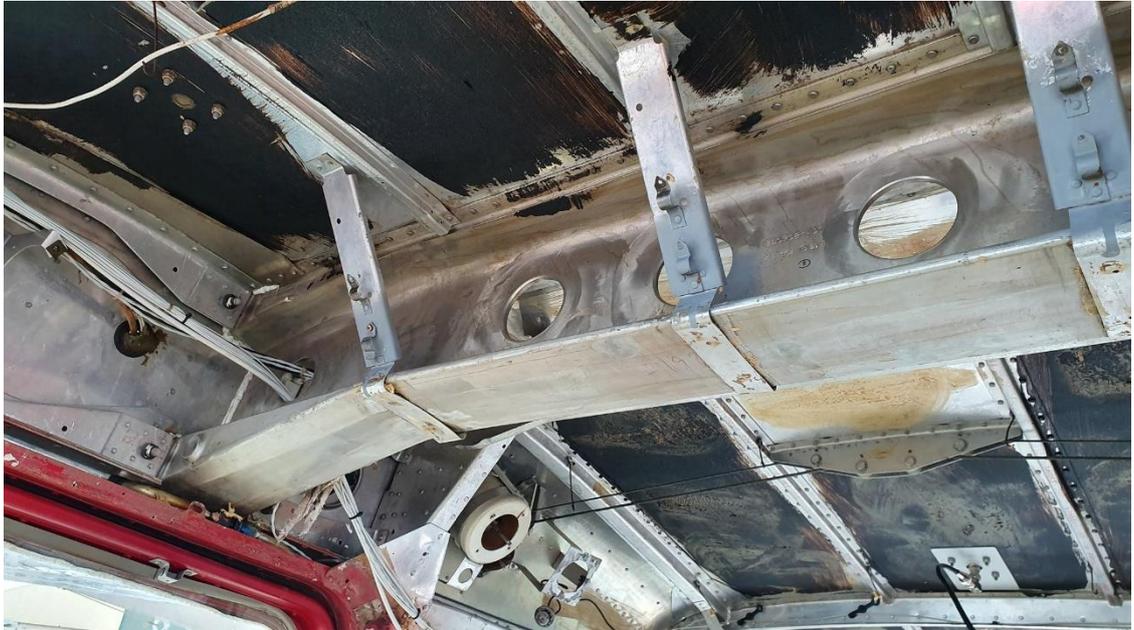
- Some aircraft have modifications to ensure the cabin headliner is securely attached to the forging which may promote retention of water and chaffing against the carry-thru structure thereby exacerbating the potential corrosion problem (Figure 7).

Figure 7: Photograph of strap configuration on some aircraft.
