# AIRWORTHINESS BULLETIN

Metro 23 Engine Over Torque  
Recording in the FDR

**AWB** 31-006 **Issue :** 1  
**Date :** 8 October 2013

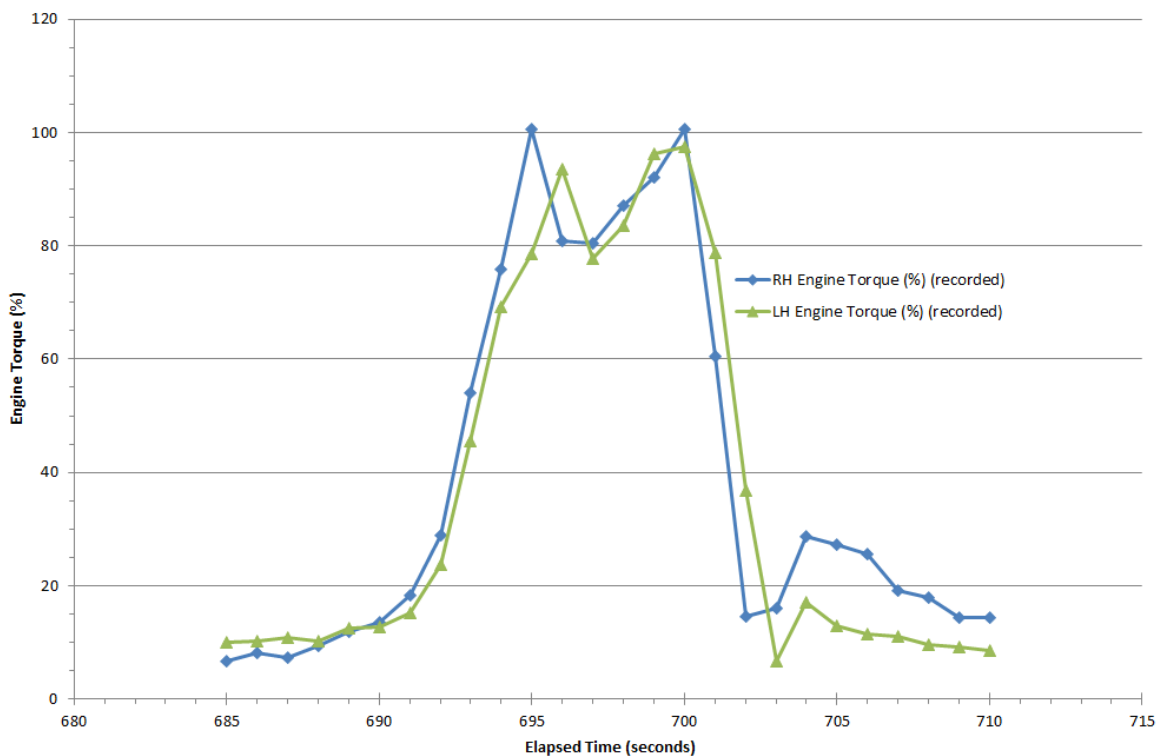
Figure 3 - Plot of Flight Data Recorder information from Rejected takeoff

The result is such that a cockpit indication of greater than 100% torque would be recorded with the same characteristic as a reduction in torque. A manual interpretation of the recorded values of engine torque is needed to assess whether an engine over-torque event has occurred.

The characteristic of the reduction in torque from the value recorded at 100%, seen in Figure 3, was unusual when compared with a normal take off power application as shown in Figure 4

The recorded torque for the left engine shows a smooth increase, peaking at about 100% torque and subsequently decreasing to about 90% torque. The right engine torque shows a smooth increase until a value of about 96% torque when the trace appears to 'dip' while still rising to a maximum value of about 101%, a similar characteristic as observed during the rejected take off. The right engine torque subsequently follows the trend of the left engine torque and decreases to about 90% torque.

Operators need to be aware when analysing engine over torque values from the FDR that engine torque values greater than 100% could appear as an under torque condition.

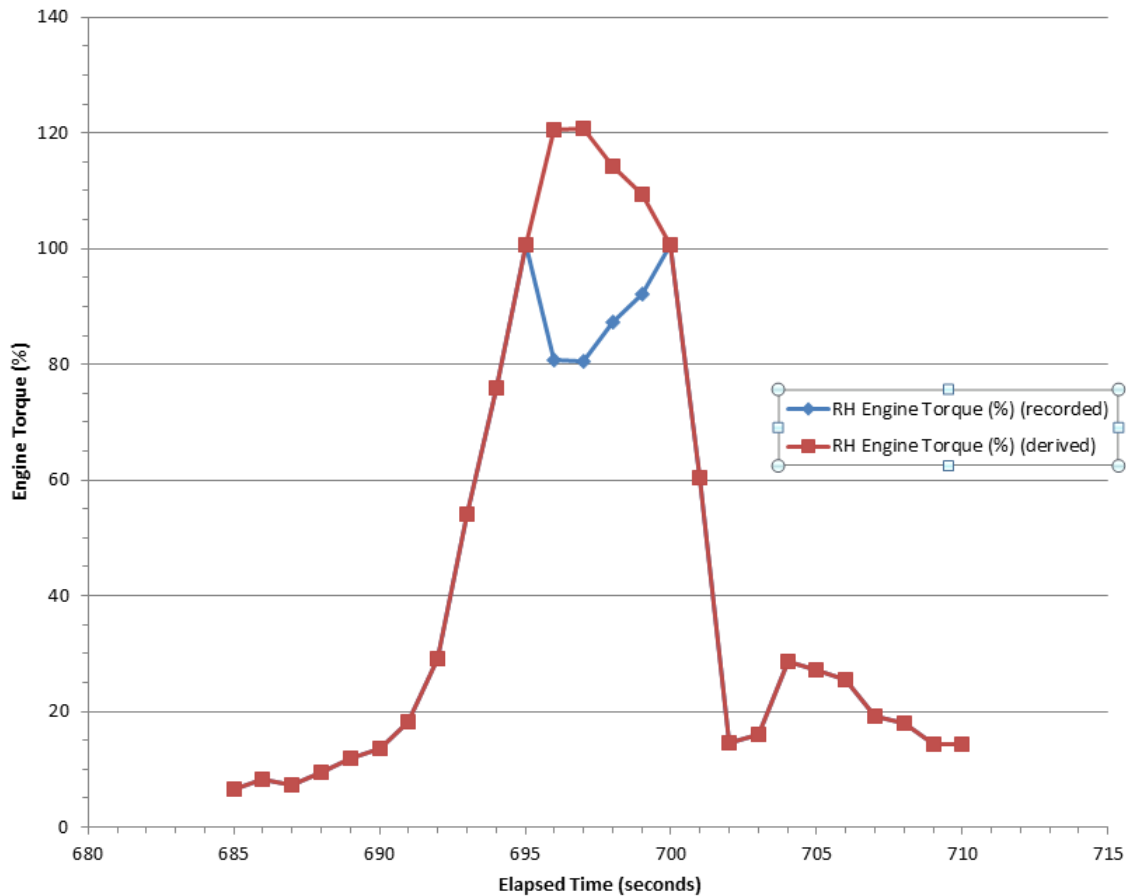
**Figure 5 - Derived to recorded engine over-torque indications**

Comparisons and calculations were made to determine the difference between the recorded engine over-torque indications and the derived indications. See Figure 5.

The values in the red trace were manually derived by determining the difference from 100% torque. These values were calculated on the basis that the flight data recorder input voltage had reduced below 0 volts dc and the torque value would have been increasing above 100%.
