Bell 206 Freewheel Unit Failures -
Mast Yielding / Main Rotor Separation

AWB 63-002 Issue : 3
Date : 27 November 2013

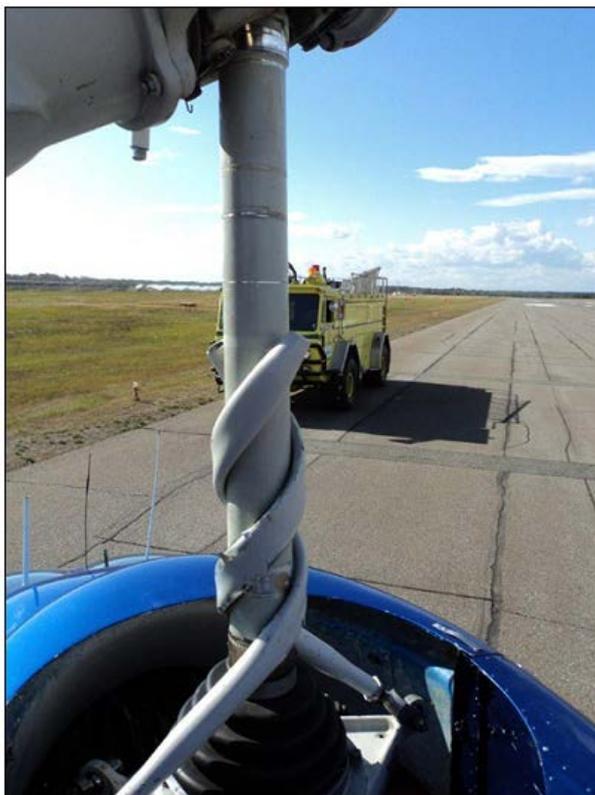
During the final stages of a practice power-recovery autorotation, the pilot rolled the throttle to full power. The engine spooled up to 100% but the free-wheel unit did not engage the engine to the transmission.

Rotor RPM decayed as the collective was raised to cushion the landing at the end of the descent, at which point the freewheel unit suddenly engaged.

The inertia built up by the engine was immediately resisted by the mass of the decelerating rotor system and the shock resulted in the main rotor head separating from the mast. The touchdown was firm and the helicopter slid about 5 feet.

Fig 1. Main rotor mast to rotor head separation failure. Accompanying text is a summary based on TSB Aviation Investigation Report A11C0152.

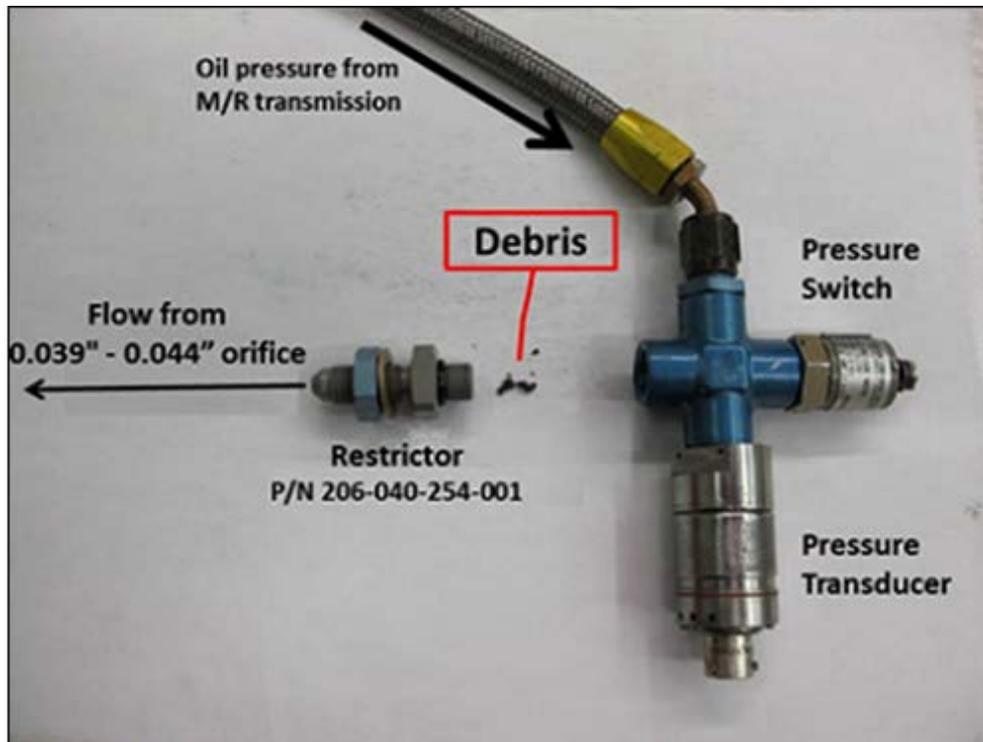
The investigation found that the free wheel unit had failed due to lack of lubrication caused by debris in the oil supply restrictor or oil jet, the same prime causal factor for freewheel failures and mast yielding in Australia.

Fig. 2 General arrangement of the failed freewheel oil supply, also note the debris blocking the restrictor or oil jet. (Ref. TSB Aviation Investigation Report A11C0152).

1. Performing a physical check of the transmission to determine if the freewheel unit oil supply filter is installed.
2. Installing the filter in accordance with TB 206-79-31, with the improved filter as per IL 206-05-92
3. In addition to the current Bell requirement to inspect the one-way clutch oil supply orifice filter for cleanliness at overhaul, CASA recommends that the operator take action to ensure the filter is checked for cleanliness:
 - (i) Between 100 to 200 flying hours after the transmission has been opened for maintenance,
 - (ii) Following main transmission failure,
 - (iii) Whenever the main transmission is changed, or
 - (iv) The freewheel unit is removed or changed for any reason.
4. Activating the associated chip detector.

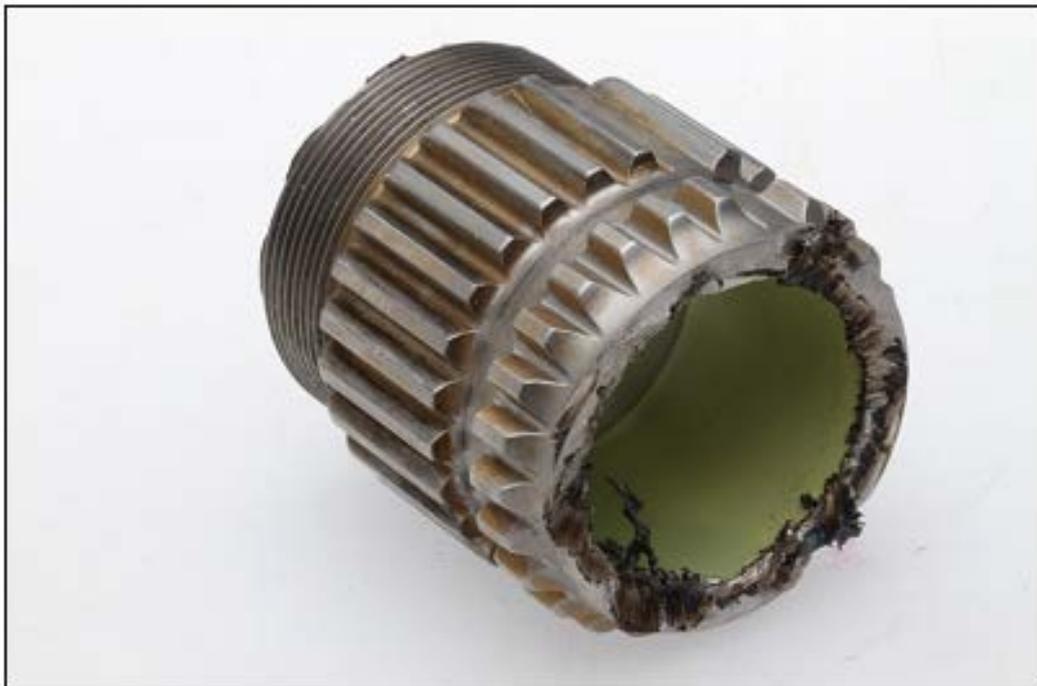
Free wheel failure of this kind usually results in a torsional yield failure of the main rotor mast, evidenced by a misalignment between the mast spline that engages with the main rotor head and the comparison spline in the mast below where the main rotor head engages with the mast splines. (See figure 3).

Fig. 3 Upper mast stub which separated from the main rotor mast. (Ref. TSB Aviation Investigation Report A11C0152).
