SAIB: CE-14-07

SUBJ: WING SPAR – Main Spar Lower Cap Cracks

This Special Airworthiness Information Bulletin (SAIB) alerts you, owners and operators of certain **Piper Aircraft, Inc. (Piper) Models PA-31*, PA-31-300, PA-31-325, and PA-31-350** airplanes, of cracking discovered in the wing main spar lower cap at the aircraft centerline spar splice plate. This SAIB also provides guidance on recommended inspections for these Piper airplane models at the damage location.

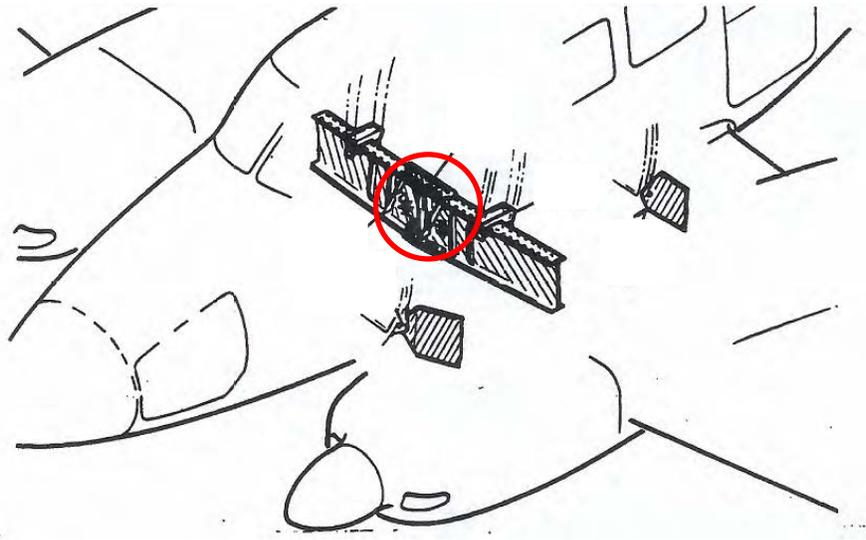
During a teardown of a Piper Model PA-31-350, two crack indications were discovered in the main spar lower cap fastener holes common to the centerline splice plate (See Figures 1 through 3 to better identify the damage location). The indications resulted from the bolt hole eddy current inspection (BHEC) method in report DOT/FAA/AR-07/64 "Teardown Examination of a 1975 Piper Navajo Chieftain Model PA 31-350 Airplane". The cracks were confirmed by metallurgical lab evaluation.

Figure 1 – Aircraft-level view of damage area

The aircraft should be jacked and shored per the maintenance manual to relieve the weight of the wings. The FAA recommends using the eddy current inspection methods in DOT/FAA/AR-07/64. Specifically, reference the following methods in Appendix A:

Repair or replace damaged components if you find damage (cracks, corrosion, etc.). Piper Aircraft, Inc. has experience with repairs and rework in this area. Report damage to the FAA as a Malfunction/Defect Report (MDR) or Service Difficulty Report (SDR).

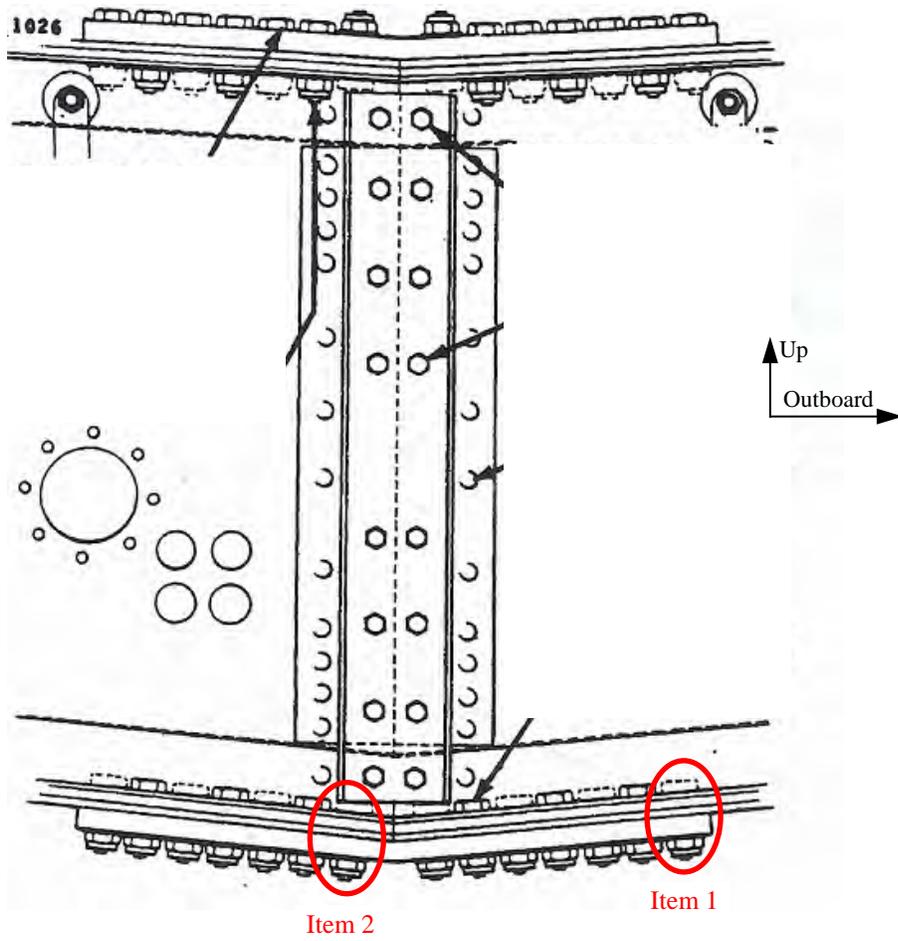
Item 1: The first crack was discovered in the right wing main spar lower "T-shaped" cap (Piper P/N 40420-23) in the outboard-most fastener hole common to the spar splice plate. This damage measured 0.020" and was confirmed as a standard fatigue crack.

Item 2: The second crack was discovered in the left wing main spar lower cap "L-shaped" aft reinforcing angle (Piper P/N 44677-16) in the inboard-most fastener hole common to the spar splice plate. This damage measured 0.054" deep x 0.34" long and was confirmed as a stress corrosion crack.

Figure 2 – Detail view of damage area (view looking aft)

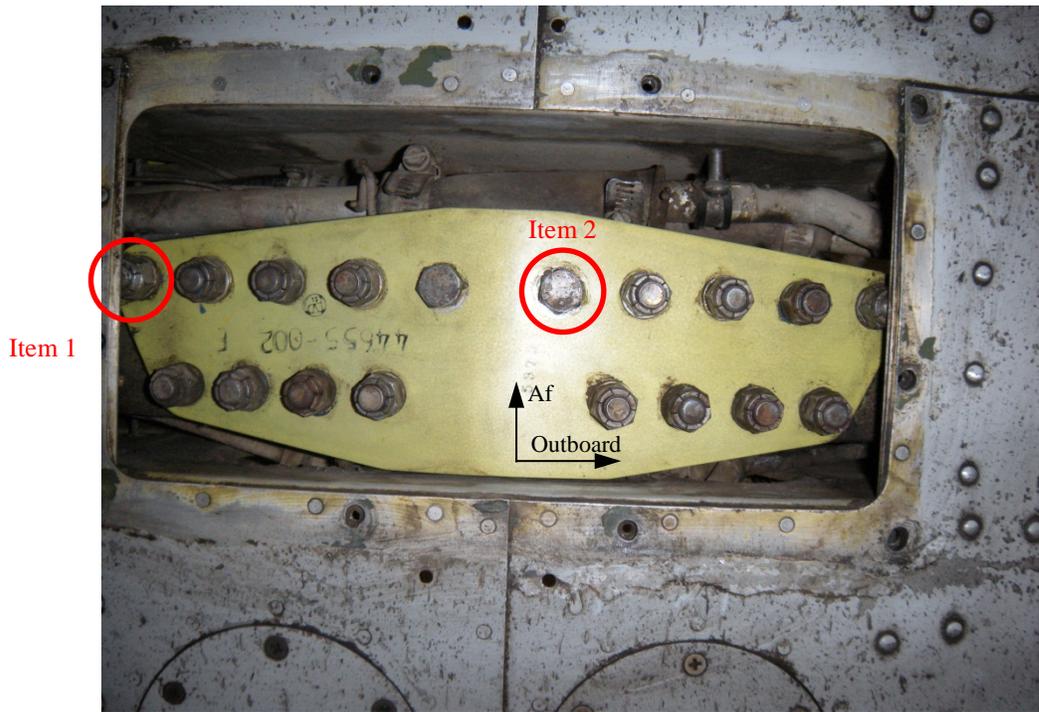
Figure 3 – Detail photographic view of damage area (*view looking up*)
