FAA
Aviation Safety

SPECIAL AIRWORTHINESS INFORMATION BULLETIN

SUBJ: POWERPLANT - ENGINE MOUNT – Cracking at nose landing gear attachment and trunnion attachment **SAIB:** CE-09-13R1
Date: July 14, 2014

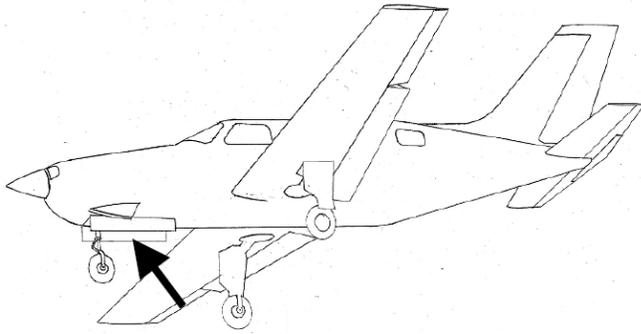
This SAIB is a result of reported cracks being found in the engine mount, both where the actuator for the nose landing gear attaches and at the pivot where the NLG trunnion attaches. Figures 1a and 1b below show the general area.

Figure 1a. General location of engine mount

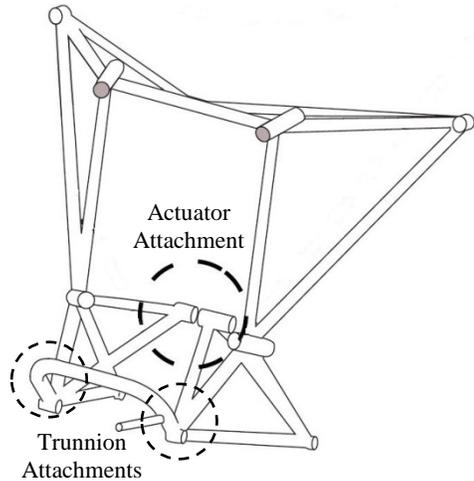
Figure 1b. Typical engine mount crack locations

After reviewing the above data, we recommend that you inspect the engine mount where the nose landing gear trunnion and actuator attach. We also recommend that you replace the mount with a new mount that relieves the repetitive inspection, where applicable. You should perform the inspection and replacement following the appropriate Piper service information SL 1001, SB 1103, and/or SB 1154 for the model and serial number of your aircraft and the configuration of your engine mount.

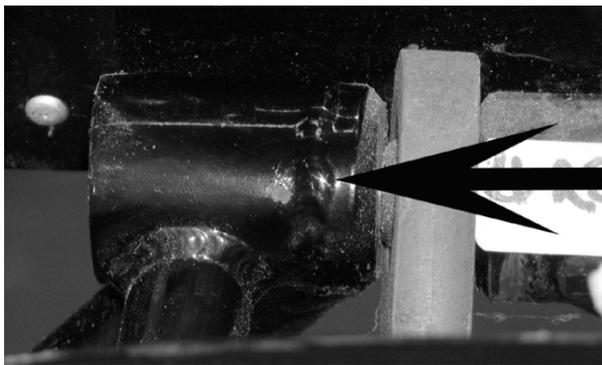
The first type, and the subject of SB 1103, is cracking around the circumference of the “foot” (the metal tube where the actuator bolt attaches). The “foot” cracks occur on some early engine mounts where the “foot” is made up of two parts; a metal disk welded to a metal tube. The cracks have been found in the welded area between the disk and tube. Some aircraft have a one-piece machined foot and have not experienced this problem. See Figures 2a and 2b below (from SB 1103C) showing pictures of both welded and machined configurations.

Figure 2a. Original Engine Mount Weld Indicates Two (2) Piece Foot

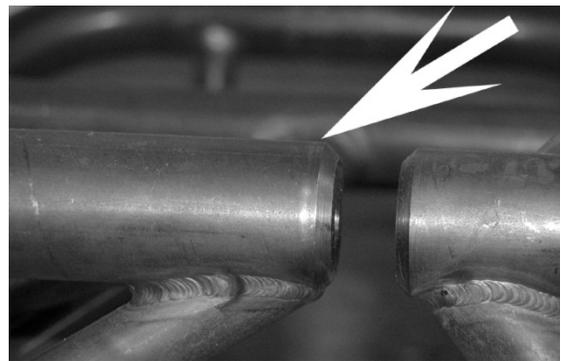
Figure 2b. Interim redesign Engine Mount One (1) Piece Machined Foot

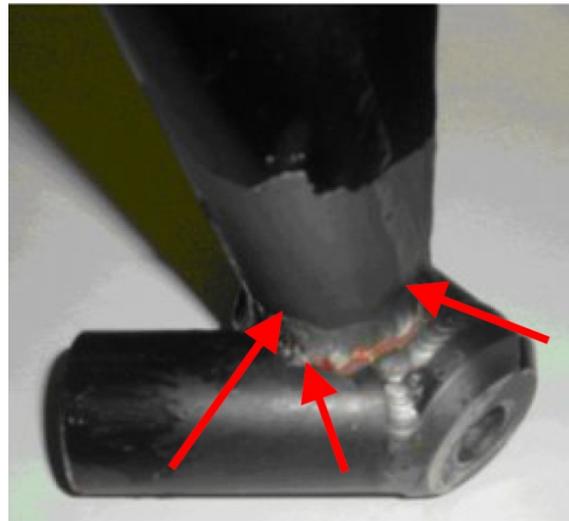
The second type of cracking is in the actuator cluster weld, which attaches the “foot” to the engine mount tubing, and is the subject of service bulletins 1103 and 1154. This second type of cracking occurs in the welded joints where the foot attaches to the engine mount tubes (cluster weld). See Figure 3 below. This type of cracking is independent of whether the foot is welded or machined.

Figure 3. Cracks around Tube Cluster
(Note: crack extends into tube)
