Precision Airmotive RSA-10AD1 Fuel Control Unit – Possible Fuel Flow Restriction

AWB 73-007 **Issue :** 1
Date : 21 July 2014

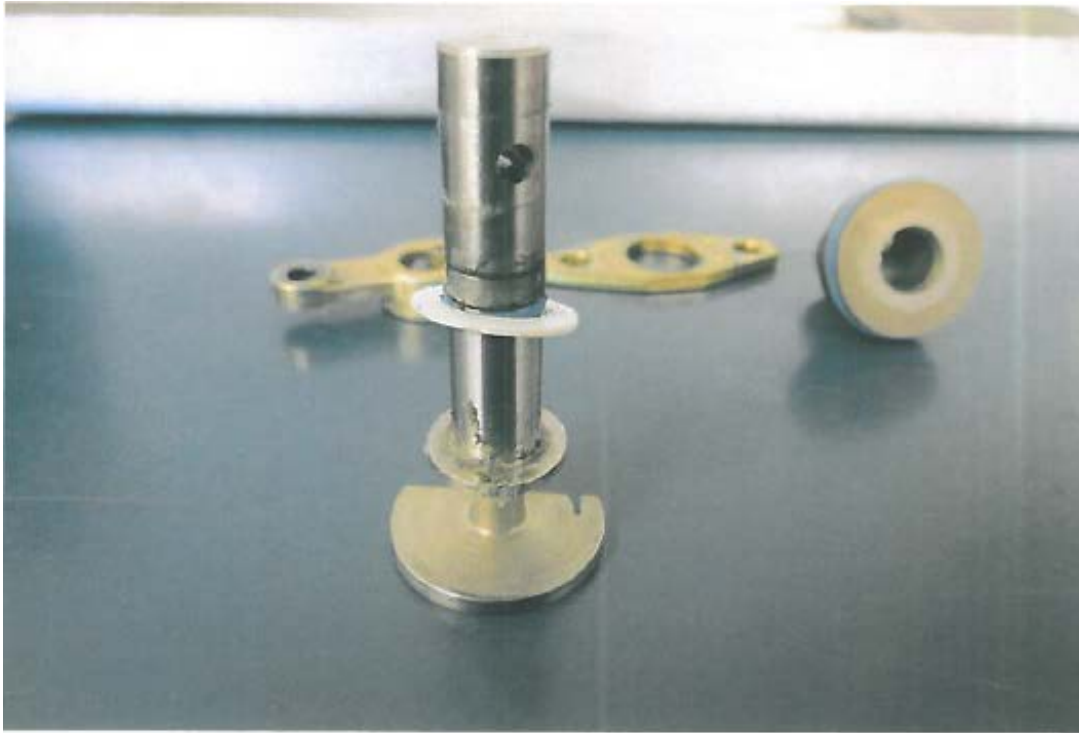
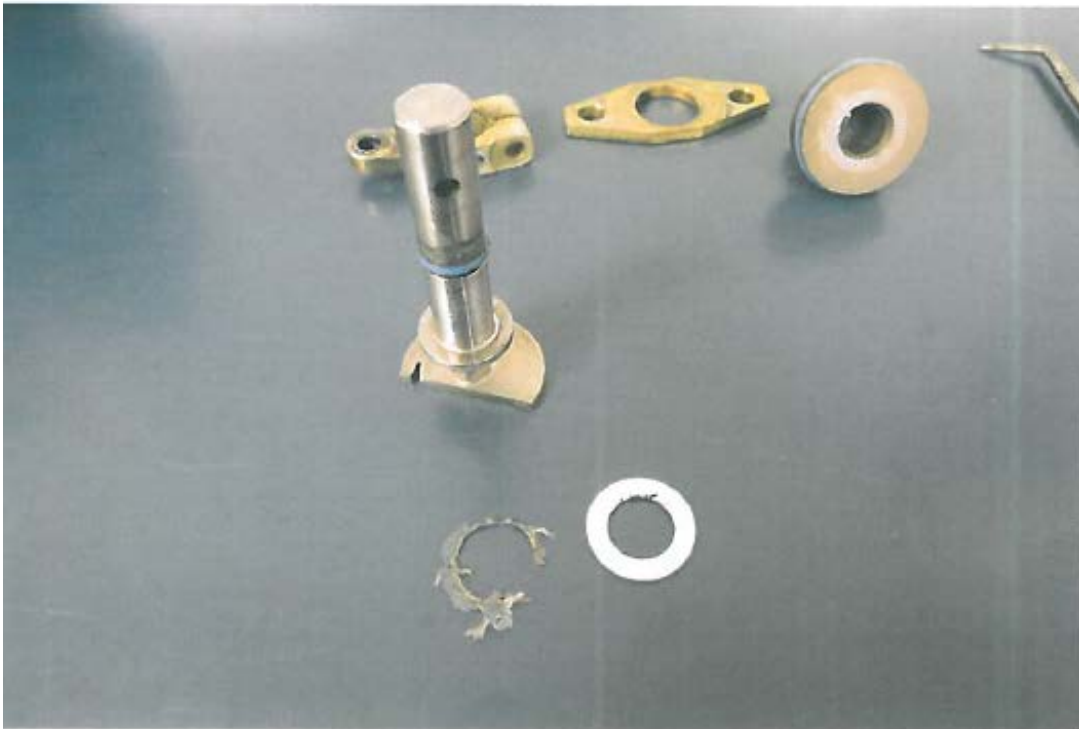
This AWB is prompted by an incident reported to the New Zealand Civil Aviation Authority (NZ CAA) of a loss of engine power on a Robinson R44 II which resulted in the pilot carrying out a successful auto-rotation landing. A subsequent examination of the FCU revealed material disintegration from washer P/N 367757 which was ingested through the fuel system and resulted in a loss of engine power.

The material found was similar in appearance to Polytetrafluoroethylene (PTFE) thread-tape. A laboratory analysis determined that the composition of the material as PTFE, a thermoplastic polymer associated with washer P/N 367757. See figure 1.

This washer is fitted to the fuel cylinder injector in the FCU and is located downstream of the internal fuel strainer. Hence, any liberated washer material may be carried through the FCU and to the fuel nozzles without further filtration.

Figure 1 - Defective washer p/n 367757 with example of liberated material

Incorporate the inspection requirements of Precision Airmotive Service Bulletin PRS-109 into the elected R44 maintenance program. Note the corrective actions in section C.ii) of the document If the throttle control movement becomes excessively stiff at any time between the inspections.
