AIRWORTHINESS BULLETIN

AWB 31-009 Issue 1 – 28 March 2017

Horizontal Situation Indicator – Premature Drive Belt failure

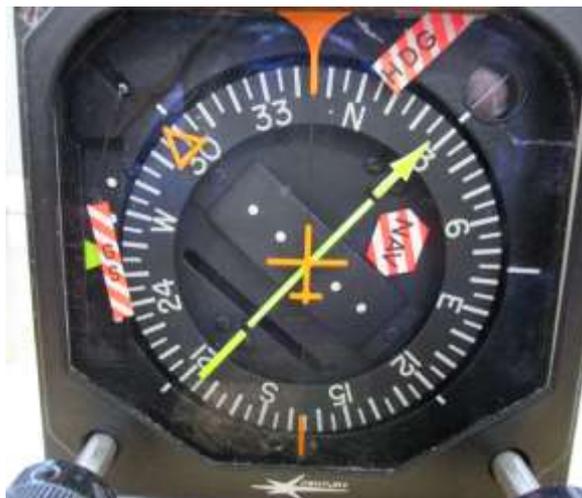
Figure 1 - HSI model NSD360

CASA has received reports from various approved maintenance organisations that drive belts fitted to HSI model NSD360 (see Figure 1) are failing prematurely in service.

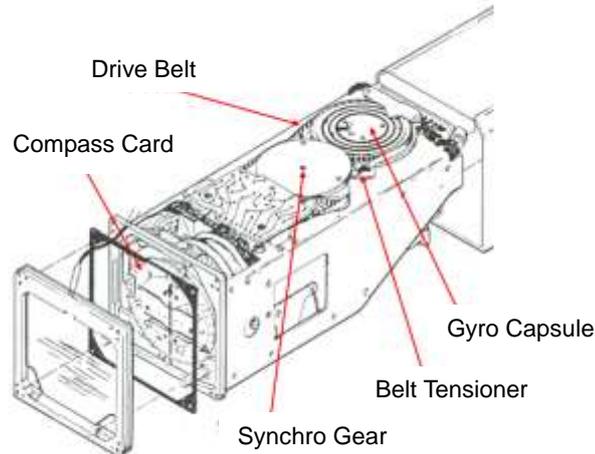
Figure 2 - HSI drive belt related components

The drive belt drives the compass card on the HSI through 360° of rotation in conjunction with the drive gear motor assembly see Figure 2.

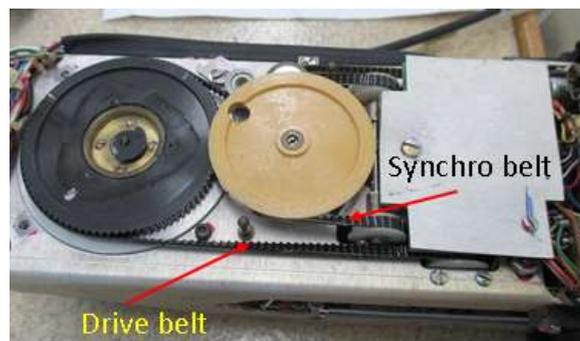
Figure 3 - Gyro and motor assembly gear

The gyro drive belt is connected to the gyro assembly via a toothed gear that is mounted on top of the gyro capsule/casing see Figure 3.

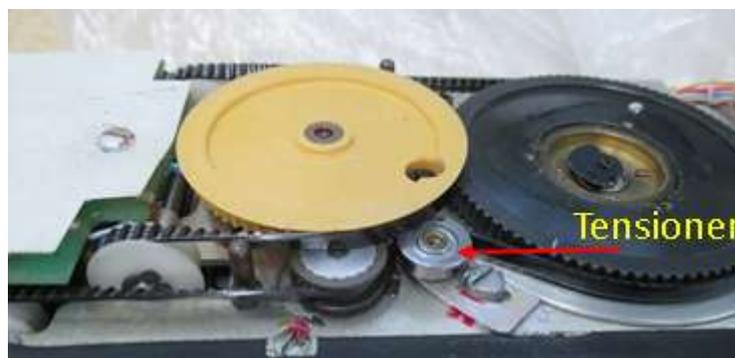
Figure 4 - Belt tensioner

The belt is then tensioned (see Figure 4) around the motor assembly gear and tensioned to medium tension with the belt tensioner bearing and bracket. The belt is held under tension at all times both in operation and in static/standby mode.

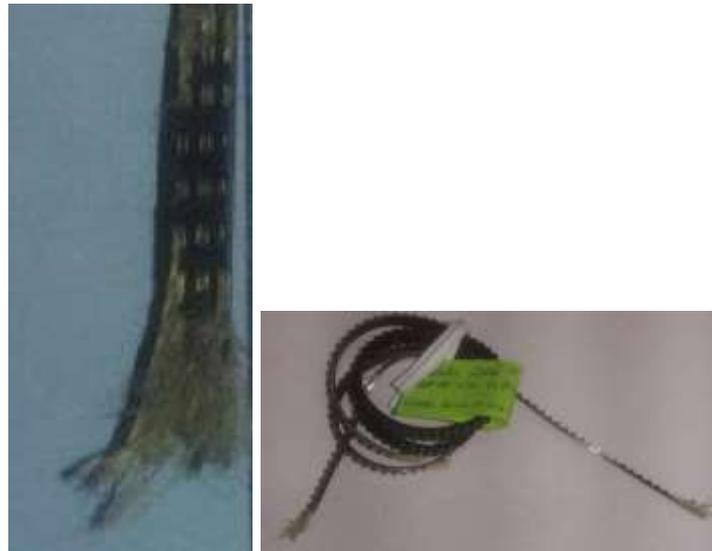
Figure 5 - Broken belt

The drive belt part number: 30B437 are currently lasting between 3 to 12 months in service before failing. After approximately 60-100 hours, the belts are starting to fray and weaken, resulting in failure soon after. These issues are identified with Certificate of Conformance number 4100, 3803, 3117 and 2508; however this issue may relate to other batch numbers.

- Stripped teeth
- Fraying on edges – see Figure 6
- Broken reinforcing strings
- Broken belt – see Figure 5

In some instances, the individual cords can snap and become wrapped around other critical components, or the belts can stretch or break completely causing loss of indicated direction.

CASA encourages reporting any service difficulties with drive belt failures via the [Defect Reporting](#) system.

Please quarantine any failed or damaged drive belts for further investigation.

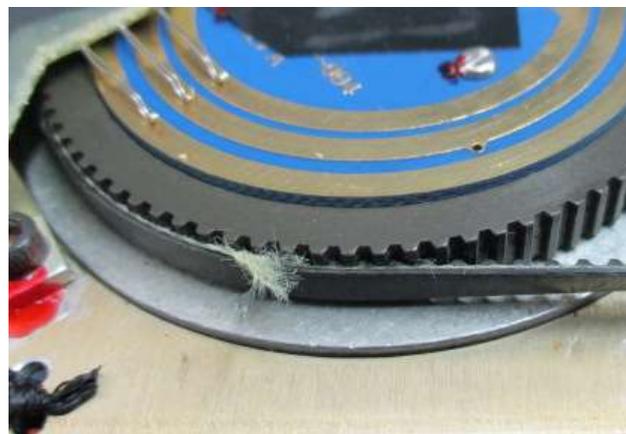
Figure 6 - Fraying belt

When the belts fray, the cords can get caught around the brush assembly P/N 81B340 - which is mounted on top of the gyro can - or other critical parts within the HSI.

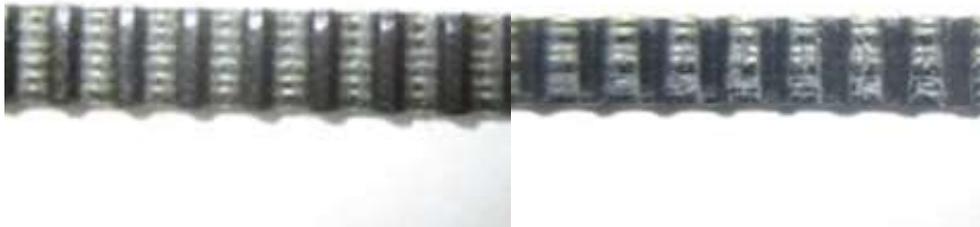
The belt is comprised of a number of load carrying tensile cords. The construction of the belt has changed see Figure 7.

Figure 7 - Newer timing belt above right compared to older timing belt with finer tensile cords shown on left
